Access Compliance Report Public Rights-of-Way (Curb Ramps)

Intersection ID: 48457 Main Street: FOX POINT DR **Cross Street: PANGLEMONT DR** Location: SE Ramp Type: PerpDiag Initial Pass/Fail: Fail **Overall Compliance: No** Severity Score: 21.25 ADA ID: 35AA4E647935

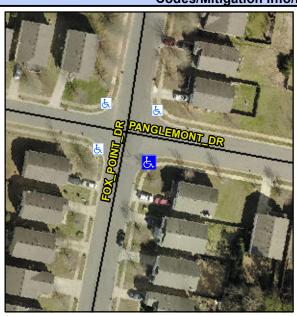
Field Measurements/Component Compliance						
	Compliance Description		Data	Comp	liance Description	Data
	N/A	Ramp Length (in)	47.0	No	Ramp Slope (%)	11.7
	No	Ramp Width (in)	47.5	Yes	Ramp XSlope (%)	1.0
	N/A	Flare Type LT	N/A	N/A	Flare Type RT	N/A
	N/A	Flare Slope LT (%)	N/A	N/A	Flare Slope RT (%)	N/A
	N/A	Flare Traversable LT?	N/A	N/A	Flare Traversable RT?	N/A
	N/A	Landing Length (in)	N/A	N/A	DWS Provided?	N/A
	N/A	Landing Width (in)	N/A	N/A	DWS Contrast?	N/A
	N/A	Landing Slope (%)	N/A	N/A	DWS Length (in)	N/A
	N/A	Landing X Slope (%)	N/A	N/A	DWS Full Width?	N/A
	N/A	Landing Curb? (Y/N)	N/A	N/A	DWS Offset (in)	N/A
	N/A	Shared Landing?	N/A			
	N/A	Gutter Ponding?	N/A	N/A	Gutter Slope (%)	N/A
	N/A	Gutter Lip Ht (in)	N/A	N/A	Gutter X Slope (%)	N/A
	N/A	Painted X Walk1?	No	N/A	Painted X Walk2?	No
		X Walk 1 Direction	To N		X Walk 2 Direction	To NW
	N/A	X Walk 1 Width (in)	N/A	N/A	X Walk 2 Width (in)	N/A
		X Walk 1 Slope (%)	1.4		X Walk 2 Slope (%)	2.9

X Walk 1 X Slope (%)	1.3		X Walk 2 X Slope (%)	0.3
	N/A	Ramp inside XWalk1?	N/A	N/A	Ramp inside XWalk2?	N/A
		Road Slope (%)	2.1	N/A	Clear Space?	N/A
		Road X Slope (%)	2.3	N/A	Clear Space to XWalk (in)	N/A
	N/A	Any Obstructions?	N/A	N/A	Storm Grate/Utility Hazard?	N/A
		Obstruction Type			Storm Grate/Utility Type	
			N/A			N/A
				Yes	Surface Condition? (G/P)	Good
		State Belleville Control of the Cont

Possible Solutions: **Remove & Replace Curb Ramp With Two New Directional Ramps or** Equivalent. Surveyor Notes: N/A PROW/ADA: Not Found, R304.5.1, R304.2.2
