# Access Compliance Report

## Public Rights-of-Way

### (Curb Ramps)

Intersection ID: 31427	Main Street: CHEVIOTT_HILL_LN	Cross Street: RIDING_HILL_AV	Location: S
ADA ID: 35AB935A824E	Ramp Type: PerpDiag	Initial Pass/Fail: Fail	Overall Compliance: No
Severity Score: 10			
Codes/Mitigation Info/Possible Solution		Field Measurements/Component Compliance

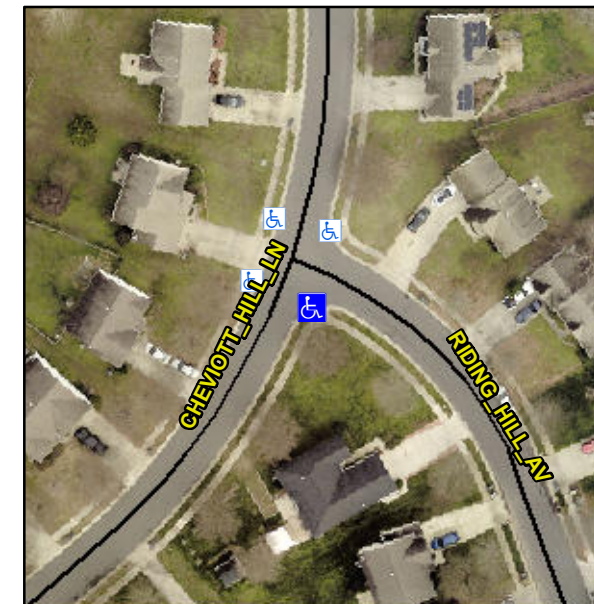
Compliance	Description	Data	Compliance	Description	Data
N/A	Ramp Length (in)	49.0	Yes	Ramp Slope (%)	6.3
No	Ramp Width (in)	47.5	No	Ramp XSlope (%)	2.8
N/A	Flare Type LT	N/A	N/A	Flare Type RT	N/A
N/A	Flare Slope LT (%)	N/A	N/A	Flare Slope RT (%)	N/A
N/A	Flare Traversable LT?	N/A	N/A	Flare Traversable RT?	N/A
N/A	Landing Length (in)	N/A	N/A	DWS Provided?	N/A
N/A	Landing Width (in)	N/A	N/A	DWS Contrast?	N/A
N/A	Landing Slope (%)	N/A	N/A	DWS Length (in)	N/A
N/A	Landing X Slope (%)	N/A	N/A	DWS Full Width?	N/A
N/A	Landing Curb? (Y/N)	N/A	N/A	DWS Offset (in)	N/A
N/A	Shared Landing?	N/A			
N/A	Gutter Ponding?	N/A	N/A	Gutter Slope (%)	N/A
N/A	Gutter Lip Ht (in)	N/A	N/A	Gutter X Slope (%)	N/A
N/A	Painted X Walk1?	No	N/A	Painted X Walk2?	No
	X Walk 1 Direction	To NE		X Walk 2 Direction	To NW
N/A	X Walk 1 Width (in)	N/A	N/A	X Walk 2 Width (in)	N/A
	X Walk 1 Slope (%)	5.6		X Walk 2 Slope (%)	8.2
	X Walk 1 X Slope (%)	2.9		X Walk 2 X Slope (%)	3.3

N/A	Ramp inside XWalk1?	N/A	N/A	Ramp inside XWalk2?	N/A
	Road Slope (%)	1.7	N/A	Clear Space?	N/A
	Road X Slope (%)	5.6	N/A	Clear Space to XWalk (in)	N/A
N/A	Any Obstructions?	N/A	N/A	Storm Grate/Utility Hazard?	N/A
	Obstruction Type			Storm Grate/Utility Type	
		N/A			N/A
		Yes		Surface Condition? (G/P)	Good

Possible Solutions:

**Remove & Replace Curb Ramp With Two New Directional Ramps or Equivalent.**

**Not Found, R304.5.1, R304.5.3**
