Access Compliance Report Public Rights-of-Way (Curb Ramps)

Intersection ID: 13822 Main Street: W_WORTHINGTON_AV Cross Street: WICKFORD_PL Location: E

ADA ID: 35B009BE0695 Ramp Type: PerpDiag Initial Pass/Fail: Fail Overall Compliance: No Severity Score: 37.5

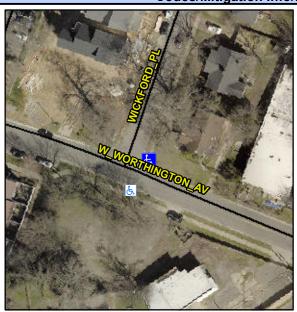
| i iola mododi omonto/oomponont oomphanoo | | | | | | |
|--|---|---|---|---|---|--|
| N/A | Ramp Length (in) | 69.0 | No | Ramp Slope (%) | 8.5 | |
| Yes | Ramp Width (in) | 48.0 | No | Ramp XSlope (%) | 11.0 | |

Remove & Replace Curb Ramp With Two New Directional Ramps or Equivalent.

R304.2.2, R304.5.3
