Access Compliance Report

Public Rights-of-Way

(Curb Ramps)

Intersection ID: 21797	Main Street: GALLERIA_BV	Cross Street: MONROE_RD	Location: SW
ADA ID: 35B1778CF3D0	Ramp Type: Perp	Initial Pass/Fail: Fail	Overall Compliance: No
Codes/Mitigation Info/Possible Solution		Field Measurements/Component Compliance	
Severity Score: 13.75

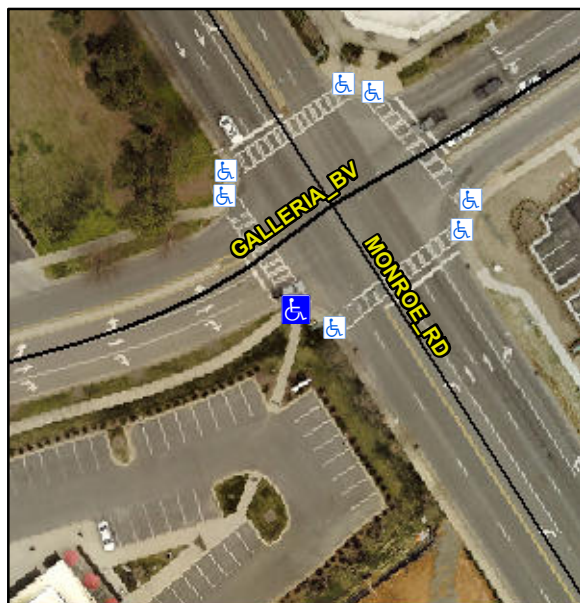
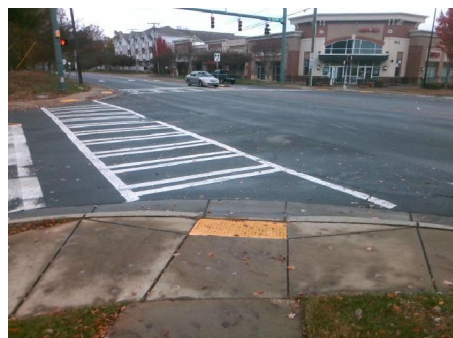
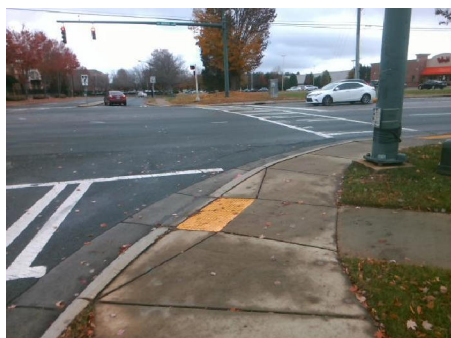
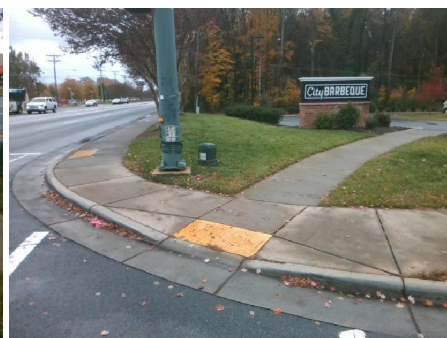
Not Found, R304.2.2

Compliance	Description	Data	Compliance	Description	Data
N/A	Ramp Length (in)	26.0	No	Ramp Slope (%)	8.7
Yes	Ramp Width (in)	48.0	Yes	Ramp XSlope (%)	2.3
N/A	Flare Type LT	N/A	N/A	Flare Type RT	N/A
N/A	Flare Slope LT (%)	N/A	N/A	Flare Slope RT (%)	N/A
N/A	Flare Traversable LT?	N/A	N/A	Flare Traversable RT?	N/A
N/A	Landing Length (in)	N/A	N/A	DWS Provided?	N/A
N/A	Landing Width (in)	N/A	N/A	DWS Contrast?	N/A
N/A	Landing Slope (%)	N/A	N/A	DWS Length (in)	N/A
N/A	Landing X Slope (%)	N/A	N/A	DWS Full Width?	N/A
N/A	Landing Curb? (Y/N)	N/A	N/A	DWS Offset (in)	N/A
N/A	Shared Landing?	N/A			
N/A	Gutter Ponding?	N/A	N/A	Gutter Slope (%)	N/A
N/A	Gutter Lip Ht (in)	N/A	N/A	Gutter X Slope (%)	N/A
N/A	Painted X Walk1?	Yes	N/A	Painted X Walk2?	N/A
	X Walk 1 Direction	To NW		X Walk 2 Direction	N/A
N/A	X Walk 1 Width (in)	113.0	N/A	X Walk 2 Width (in)	N/A
	X Walk 1 Slope (%)	0.8		X Walk 2 Slope (%)	N/A
	X Walk 1 X Slope (%)	3.7		X Walk 2 X Slope (%)	N/A

N/A	Ramp inside XWalk1?	Yes	N/A	Ramp inside XWalk2?	N/A
	Road Slope (%)	N/A	N/A	Clear Space?	N/A
	Road X Slope (%)	N/A	N/A	Clear Space to XWalk (in)	N/A
N/A	Any Obstructions?	N/A	N/A	Storm Grate/Utility Hazard?	N/A
	Obstruction Type			Storm Grate/Utility Type	
		N/A			N/A
			Yes	Surface Condition? (G/P)	Good

Remove & Replace Entire Ramp.
