# Access Compliance Report

## Public Rights-of-Way

### (Curb Ramps)

Intersection ID: 20410	Main Street: CARMEL_RD	Cross Street: FAIRVIEW_RD	Location: NW
ADA ID: 35B523DB49AF	Ramp Type: Perp	Initial Pass/Fail: Fail	Overall Compliance: No
Severity Score: 12.5			
Codes/Mitigation Info/Possible Solution		Field Measurements/Component Compliance

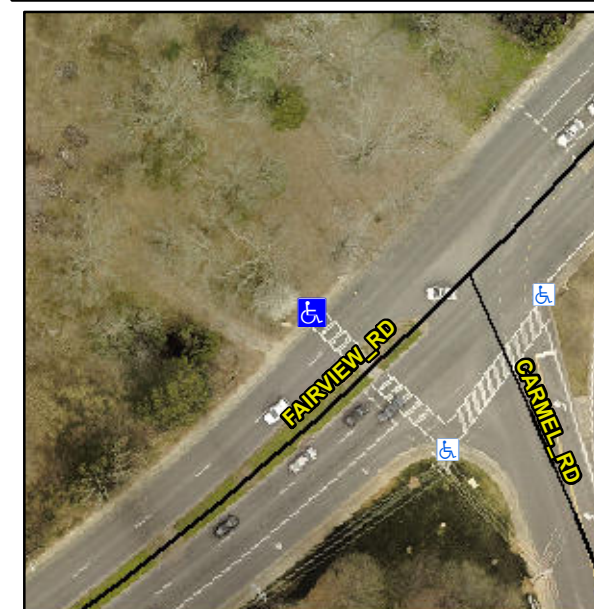
**Not Found, R304.2.2**

Compliance	Description	Data	Compliance	Description	Data
N/A	Ramp Length (in)	60.0	No	Ramp Slope (%)	8.8
Yes	Ramp Width (in)	48.0	Yes	Ramp XSlope (%)	1.4
N/A	Flare Type LT	N/A	N/A	Flare Type RT	N/A
N/A	Flare Slope LT (%)	N/A	N/A	Flare Slope RT (%)	N/A
N/A	Flare Traversable LT?	N/A	N/A	Flare Traversable RT?	N/A
N/A	Landing Length (in)	N/A	N/A	DWS Provided?	N/A
N/A	Landing Width (in)	N/A	N/A	DWS Contrast?	N/A
N/A	Landing Slope (%)	N/A	N/A	DWS Length (in)	N/A
N/A	Landing X Slope (%)	N/A	N/A	DWS Full Width?	N/A
N/A	Landing Curb? (Y/N)	N/A	N/A	DWS Offset (in)	N/A
N/A	Shared Landing?	N/A			
N/A	Gutter Ponding?	N/A	N/A	Gutter Slope (%)	N/A
N/A	Gutter Lip Ht (in)	N/A	N/A	Gutter X Slope (%)	N/A
N/A	Painted X Walk1?	Yes	N/A	Painted X Walk2?	N/A
	X Walk 1 Direction	To SE		X Walk 2 Direction	N/A
N/A	X Walk 1 Width (in)	126.0	N/A	X Walk 2 Width (in)	N/A
	X Walk 1 Slope (%)	2.6		X Walk 2 Slope (%)	N/A
	X Walk 1 X Slope (%)	0.7		X Walk 2 X Slope (%)	N/A

**Remove & Replace Entire Ramp.**

Total Cost: \$ 1850.00
