Access Compliance Report Public Rights-of-Way (Curb Ramps)

Intersection ID: 13305 Main Street: W_BLAND_ST **Cross Street: WINNIFRED ST** Location: Ε **ADA ID: 35BFEA5195F5** Ramp Type: PerpDiag Initial Pass/Fail: Fail **Overall Compliance: No Severity Score:** 12.5

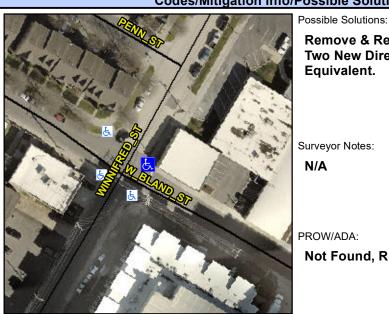
Not Found, R304.2.2

| Field Measurements/Component Compliance | | | | | |
|---|---|---|---|---|---|
| N/A | Ramp Length (in) | 48.0 | No | Ramp Slope (%) | 9.7 |

Street 1 Name Stop Condition-Street 2 Street 2 Name Stop Condition-Street 1 **WINNIFRED ST** StopSign W BLAND ST StopSign Remove & Replace Curb Ramp With Two New Directional Ramps or Equivalent.
