# Access Compliance Report

## Public Rights-of-Way

### (Curb Ramps)

| Intersection ID: 11696 | Main Street: W_5TH_ST | Cross Street: WILKES_PL | Location: S |

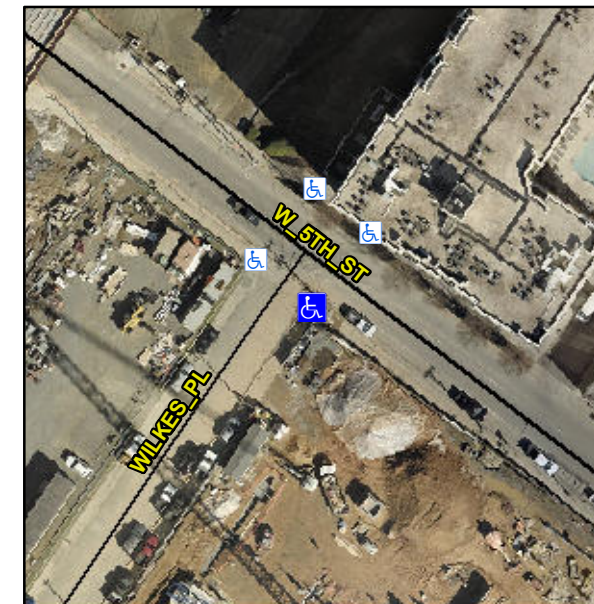
| ADA ID: 35C21C69A34C | Ramp Type: PerpDiag | Initial Pass/Fail: Fail | Overall Compliance: No |
| | | | Severity Score: 21.25 |

**Not Found, R304.5.1, R304.2.2**

| Compliance | Description | Data | Compliance | Description | Data |
|---|---|---|---|---|---|
| N/A | Ramp Length (in) | 31.0 | No | Ramp Slope (%) | 9.9 |
| No | Ramp Width (in) | 38.0 | Yes | Ramp XSlope (%) | 0.4 |

**Remove & Replace Curb Ramp With Two New Directional Ramps or Equivalent.**

Total Cost: \$ 3200.00
