# Access Compliance Report

## Public Rights-of-Way

### (Curb Ramps)

Intersection ID: 44218	Main Street: ATHERTON_MILL_RD	Cross Street: ROZZELLES_LANDING_DR	Location: NW
ADA ID: 35D0D8FE6657	Ramp Type: Perp	Initial Pass/Fail: Fail	Overall Compliance: No
Severity Score: 21.25			
Codes/Mitigation Info/Possible Solution		Field Measurements/Component Compliance

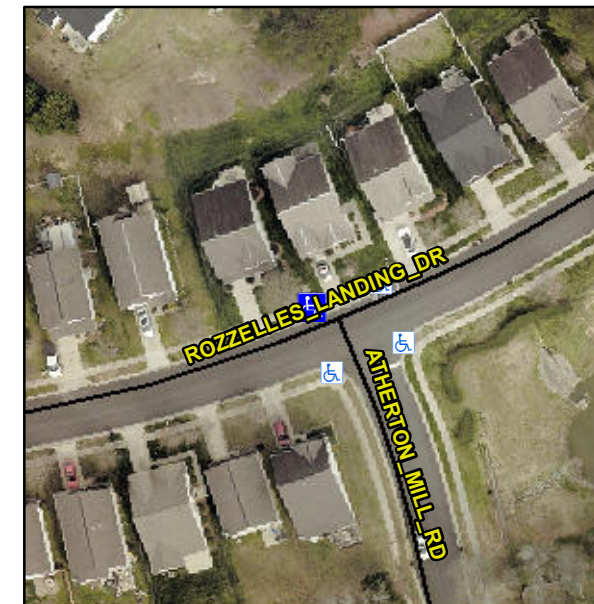
**Not Found, R304.5.1, R304.2.2**

Compliance	Description	Data	Compliance	Description	Data
N/A	Ramp Length (in)	46.5	No	Ramp Slope (%)	11.1
No	Ramp Width (in)	47.0	Yes	Ramp XSlope (%)	1.6
N/A	Flare Type LT	N/A	N/A	Flare Type RT	N/A
N/A	Flare Slope LT (%)	N/A	N/A	Flare Slope RT (%)	N/A
N/A	Flare Traversable LT?	N/A	N/A	Flare Traversable RT?	N/A
N/A	Landing Length (in)	N/A	N/A	DWS Provided?	N/A
N/A	Landing Width (in)	N/A	N/A	DWS Contrast?	N/A
N/A	Landing Slope (%)	N/A	N/A	DWS Length (in)	N/A
N/A	Landing X Slope (%)	N/A	N/A	DWS Full Width?	N/A
N/A	Landing Curb? (Y/N)	N/A	N/A	DWS Offset (in)	N/A
N/A	Shared Landing?	N/A			
N/A	Gutter Ponding?	N/A	N/A	Gutter Slope (%)	N/A
N/A	Gutter Lip Ht (in)	N/A	N/A	Gutter X Slope (%)	N/A
N/A	Painted X Walk1?	No	N/A	Painted X Walk2?	N/A
	X Walk 1 Direction	To S		X Walk 2 Direction	N/A
N/A	X Walk 1 Width (in)	N/A	N/A	X Walk 2 Width (in)	N/A
	X Walk 1 Slope (%)	0.6		X Walk 2 Slope (%)	N/A
	X Walk 1 X Slope (%)	3.5		X Walk 2 X Slope (%)	N/A

**Remove & Replace Entire Ramp.**
