Access Compliance Report Public Rights-of-Way (Curb Ramps)

Intersection ID: 10033854 Main Street: PANGLE_DR Cross Street: N/A Location: S

ADA ID: 35D6DAAE065C Ramp Type: Perp Initial Pass/Fail: Fail Overall Compliance: No Severity Score: 13.75

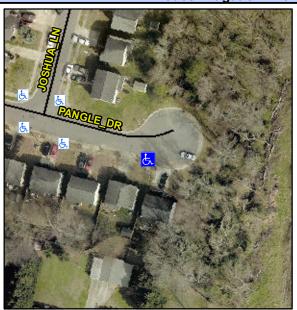
Compliance Description			Data		oliance Description	Data
N	N/A	Ramp Length (in)	47.0	No	Ramp Slope (%)	11.6
`	es/	Ramp Width (in)	48.0	Yes	Ramp XSlope (%)	2.1
N	I/A	Flare Type LT	N/A	N/A	Flare Type RT	N/A
١	N/A	Flare Slope LT (%)	N/A	N/A	Flare Slope RT (%)	N/A
١	N/A	Flare Traversable LT?	N/A	N/A	Flare Traversable RT?	N/A
١	N/A	Landing Length (in)	N/A	N/A	DWS Provided?	N/A
١	N/A	Landing Width (in)	N/A	N/A	DWS Contrast?	N/A
١	N/A	Landing Slope (%)	N/A	N/A	DWS Length (in)	N/A
١	N/A	Landing X Slope (%)	N/A	N/A	DWS Full Width?	N/A
١	N/A	Landing Curb? (Y/N)	N/A	N/A	DWS Offset (in)	N/A
١	N/A	Shared Landing?	N/A			
١	N/A	Gutter Ponding?	N/A	N/A	Gutter Slope (%)	N/A
N	I/A	Gutter Lip Ht (in)	N/A	N/A	Gutter X Slope (%)	N/A
١	N/A	Painted X Walk1?	No	N/A	Painted X Walk2?	N/A
		X Walk 1 Direction	To N		X Walk 2 Direction	N/A
١	N/A	X Walk 1 Width (in)	N/A	N/A	X Walk 2 Width (in)	N/A
		X Walk 1 Slope (%)	4.3		X Walk 2 Slope (%)	N/A

X Walk 1 X Slope (%)	3.8		X Walk 2 X Slope (%)	N/A
١	N/A	Ramp inside XWalk1?	N/A	N/A	Ramp inside XWalk2?	N/A
		Road Slope (%)	N/A	N/A	Clear Space?	N/A
		Road X Slope (%)	N/A	N/A	Clear Space to XWalk (in)	N/A
1	N/A	Any Obstructions?	N/A	N/A	Storm Grate/Utility Hazard?	N/A
		Obstruction Type		l	Storm Grate/Utility Type	
			N/A			N/A

Possible Solutions:	
Remove & Replace Entire Ramp.	
Surveyor Notes:	
N/A	
PROW/ADA:	
R304.2.2	
•

Total Cost:	\$ 1850.00
