Access Compliance Report Public Rights-of-Way (Curb Ramps)

Intersection ID: 42698 Main Street: OLD_SARDIS_RD Cross Street: PROVIDENCE_RD Location: NE

ADA ID: 35DBF479ACB5 Ramp Type: PerpDiag Initial Pass/Fail: Fail Overall Compliance: No Severity Score: 13.75

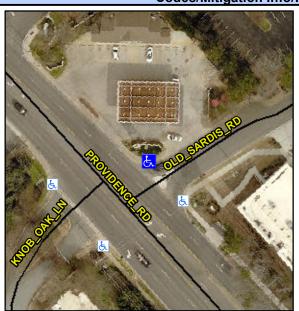
PROW/ADA:
Not Found, R304.2.2, R304.5.3

Compliance Description Data Compliance Description Data No N/A Ramp Length (in) 60.0 Ramp Slope (%) 8.7 No Ramp XSlope (%) Yes Ramp Width (in) 48.0 2.7 N/A N/A Flare Type LT N/A Flare Type RT N/A N/A N/A N/A Flare Slope RT (%) N/A Flare Slope LT (%) N/A Flare Traversable LT? N/A N/A Flare Traversable RT? N/A N/A N/A N/A DWS Provided? N/A Landing Length (in) N/A Landing Width (in) N/A N/A **DWS Contrast?** N/A N/A N/A Landing Slope (%) N/A DWS Length (in) N/A N/A Landing X Slope (%) N/A N/A DWS Full Width? N/A N/A Landing Curb? (Y/N) N/A N/A DWS Offset (in) N/A N/A N/A Shared Landing? N/A Gutter Ponding? N/A N/A Gutter Slope (%) N/A N/A Gutter Lip Ht (in) N/A N/A Gutter X Slope (%) N/A N/A Painted X Walk1? No N/A Painted X Walk2? No X Walk 1 Direction To SW X Walk 2 Direction To SE N/A N/A X Walk 1 Width (in) X Walk 2 Width (in) N/A X Walk 1 Slope (%) 0.2 X Walk 2 Slope (%) 1.8 X Walk 1 X Slope (%) 2.3 X Walk 2 X Slope (%) 1.6 N/A N/A N/A Ramp inside XWalk2? N/A Ramp inside XWalk1? Road Slope (%) 1.1 N/A Clear Space? N/A N/A Road X Slope (%) 3.5 Clear Space to XWalk (in) N/A N/A N/A N/A Any Obstructions? Storm Grate/Utility Hazard? N/A **Obstruction Type** Storm Grate/Utility Type N/A N/A Yes Surface Condition? (G/P) Good

Remove & Replace Curb Ramp With
Two New Directional Ramps or
Equivalent.
