Access Compliance Report

Public Rights-of-Way

(Curb Ramps)

Intersection ID: 43659	Main Street: TAYLOR RIDGE LN	Cross Street: STARR NEELY RD	Location: NW
ADA ID: 35DE496C3930	Ramp Type: Perp	Initial Pass/Fail: Fail	Overall Compliance: No
Severity Score: 21.25			
Codes/Mitigation Info/Possible Solution		Field Measurements/Component Compliance

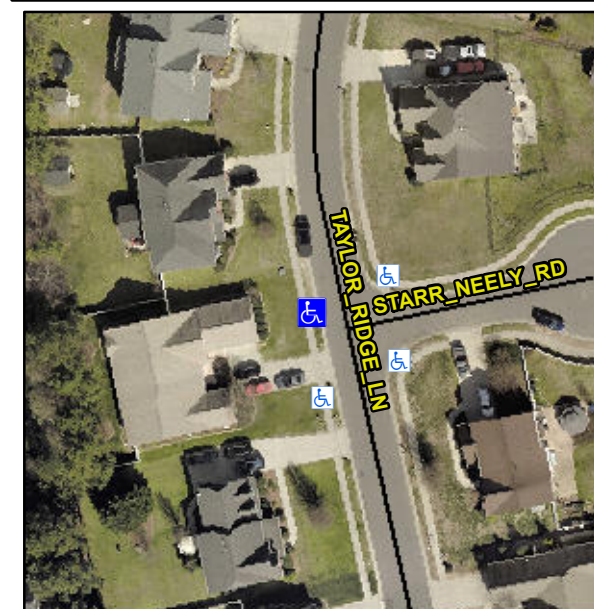
Not Found, R304.5.1, R304.2.2

Compliance	Description	Data	Compliance	Description	Data
N/A	Ramp Length (in)	46.0	No	Ramp Slope (%)	10.1
No	Ramp Width (in)	46.0	Yes	Ramp XSlope (%)	1.5
N/A	Flare Type LT	N/A	N/A	Flare Type RT	N/A
N/A	Flare Slope LT (%)	N/A	N/A	Flare Slope RT (%)	N/A
N/A	Flare Traversable LT?	N/A	N/A	Flare Traversable RT?	N/A
N/A	Landing Length (in)	N/A	N/A	DWS Provided?	N/A
N/A	Landing Width (in)	N/A	N/A	DWS Contrast?	N/A
N/A	Landing Slope (%)	N/A	N/A	DWS Length (in)	N/A
N/A	Landing X Slope (%)	N/A	N/A	DWS Full Width?	N/A
N/A	Landing Curb? (Y/N)	N/A	N/A	DWS Offset (in)	N/A
N/A	Shared Landing?	N/A			
N/A	Gutter Ponding?	N/A	N/A	Gutter Slope (%)	N/A
N/A	Gutter Lip Ht (in)	N/A	N/A	Gutter X Slope (%)	N/A
N/A	Painted X Walk1?	No	N/A	Painted X Walk2?	N/A
	X Walk 1 Direction	To E		X Walk 2 Direction	N/A
N/A	X Walk 1 Width (in)	N/A	N/A	X Walk 2 Width (in)	N/A
	X Walk 1 Slope (%)	1.9		X Walk 2 Slope (%)	N/A
	X Walk 1 X Slope (%)	0.6		X Walk 2 X Slope (%)	N/A

Possible Solutions:

Remove & Replace Entire Ramp.

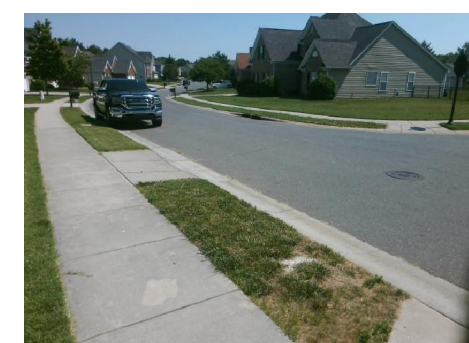
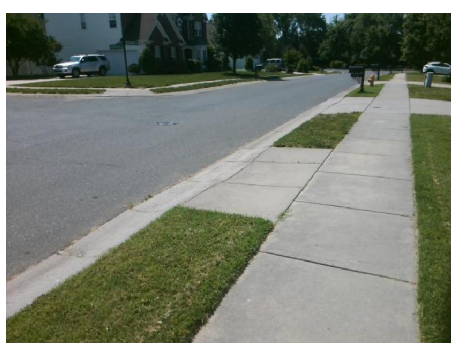
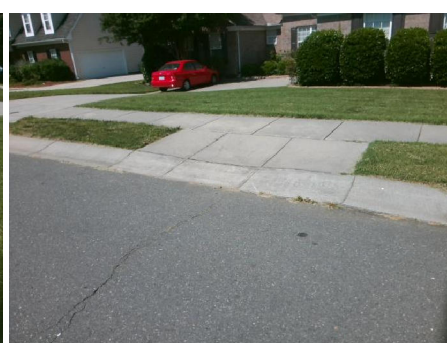
N/A	Ramp inside XWalk1?	N/A	N/A	Ramp inside XWalk2?	N/A
	Road Slope (%)	N/A	N/A	Clear Space?	N/A
	Road X Slope (%)	N/A	N/A	Clear Space to XWalk (in)	N/A
N/A	Any Obstructions?	N/A	N/A	Storm Grate/Utility Hazard?	N/A
	Obstruction Type			Storm Grate/Utility Type	
		N/A			N/A
		Yes		Surface Condition? (G/P)	Good
