Access Compliance Report Public Rights-of-Way (Curb Ramps)

Intersection ID: 14840 Main Street: N_LAUREL_AV Cross Street: VAIL_AV Location: SE

ADA ID: 35E2B40E1A9D Ramp Type: PerpDiag Initial Pass/Fail: Fail Overall Compliance: No Severity Score: 50

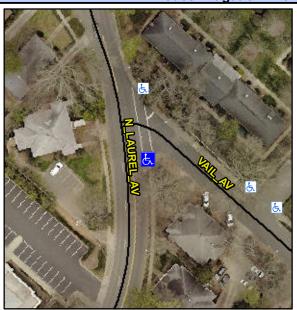
Not Found, R304.2.2, R304.5.3

Field Measurements/Component Compilance					
Compliance Description		Data	Comp	oliance Description	Data
N/A	Ramp Length (in)	33.0	No	Ramp Slope (%)	16.5
Yes	Ramp Width (in)	68.0	No	Ramp XSlope (%)	7.9
N/A	Flare Type LT	N/A	N/A	Flare Type RT	N/A
N/A	Flare Slope LT (%)	N/A	N/A	Flare Slope RT (%)	N/A
N/A	Flare Traversable LT?	N/A	N/A	Flare Traversable RT?	N/A
N/A	Landing Length (in)	N/A	N/A	DWS Provided?	N/A
N/A	Landing Width (in)	N/A	N/A	DWS Contrast?	N/A
N/A	Landing Slope (%)	N/A	N/A	DWS Length (in)	N/A
N/A	Landing X Slope (%)	N/A	N/A	DWS Full Width?	N/A
N/A	Landing Curb? (Y/N)	N/A	N/A	DWS Offset (in)	N/A
N/A	Shared Landing?	N/A			
N/A	Gutter Ponding?	N/A	N/A	Gutter Slope (%)	N/A
N/A	Gutter Lip Ht (in)	N/A	N/A	Gutter X Slope (%)	N/A
N/A	Painted X Walk1?	Yes	N/A	Painted X Walk2?	No
	X Walk 1 Direction	To N		X Walk 2 Direction	To W
N/A	X Walk 1 Width (in)	128.0	N/A	X Walk 2 Width (in)	N/A
	X Walk 1 Slope (%)	1.4		X Walk 2 Slope (%)	6.1

X Walk 1 X Slope (%)	7.3		X Walk 2 X Slope (%)	3.9
N/A	Ramp inside XWalk1?	Yes	N/A	Ramp inside XWalk2?	N/A
	Road Slope (%)	5.3	N/A	Clear Space?	N/A
	Road X Slope (%)	6.2	N/A	Clear Space to XWalk (in)	N/A
N/A	Any Obstructions?	N/A	N/A	Storm Grate/Utility Hazard?	N/A

Remove & Replace Curb Ramp With Two New Directional Ramps or Equivalent.

Total Cost: \$ 3200.00
