# Access Compliance Report

## Public Rights-of-Way

### (Curb Ramps)

Intersection ID: 11269	Main Street: GRANGER_AV	Cross Street: KEMPTON_PL	Location: S
ADA ID: 35E3118A1C78	Ramp Type: Perp	Initial Pass/Fail: Fail	Overall Compliance: No
		Severity Score: 1.25

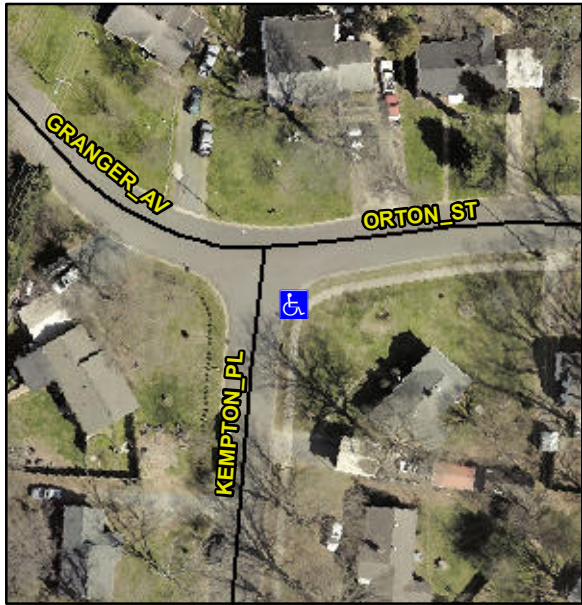
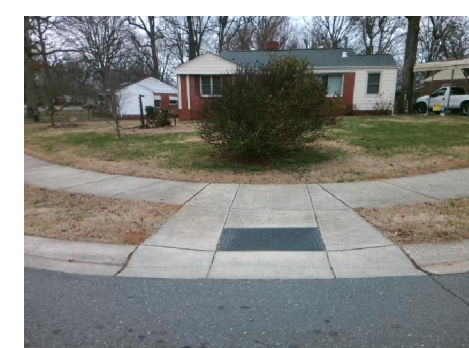
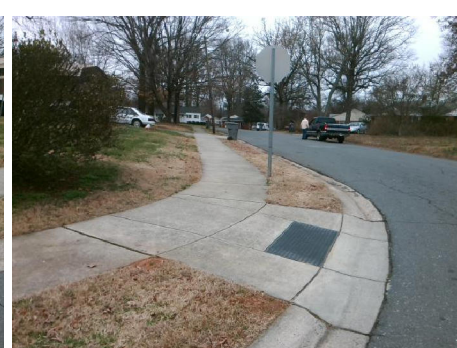
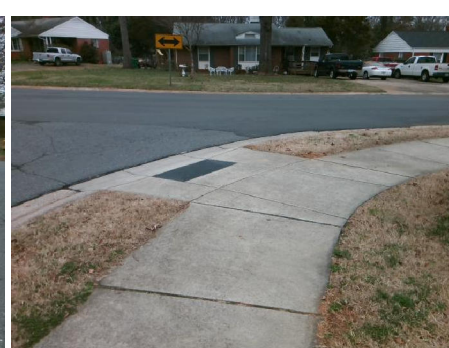
Possible Solutions:		Compliance	Description	Data	Compliance	Description	Data
	Remove & Replace Entire Ramp.		N/A	Ramp Length (in)	48.0	Yes	Ramp Slope (%)	7.9
			Yes	Ramp Width (in)	48.0	No	Ramp XSlope (%)	3.4
			N/A	Flare Type LT	N/A	N/A	Flare Type RT	N/A
			N/A	Flare Slope LT (%)	N/A	N/A	Flare Slope RT (%)	N/A
			N/A	Flare Traversable LT?	N/A	N/A	Flare Traversable RT?	N/A
			N/A	Landing Length (in)	N/A	N/A	DWS Provided?	N/A
			N/A	Landing Width (in)	N/A	N/A	DWS Contrast?	N/A
			N/A	Landing Slope (%)	N/A	N/A	DWS Length (in)	N/A
			N/A	Landing X Slope (%)	N/A	N/A	DWS Full Width?	N/A
Surveyor Notes:		N/A	N/A	Landing Curb? (Y/N)	N/A	N/A	DWS Offset (in)	N/A
PROW/ADA:		Not Found, R304.5.3	N/A	Shared Landing?	N/A			
			N/A	Gutter Ponding?	N/A	N/A	Gutter Slope (%)	N/A
			N/A	Gutter Lip Ht (in)	N/A	N/A	Gutter X Slope (%)	N/A

N/A	Painted X Walk1?	No	N/A	Painted X Walk2?	N/A
				X Walk 1 Direction	To W		X Walk 2 Direction	N/A
			N/A	X Walk 1 Width (in)	N/A	N/A	X Walk 2 Width (in)	N/A
				X Walk 1 Slope (%)	2.6		X Walk 2 Slope (%)	N/A
				X Walk 1 X Slope (%)	6.1		X Walk 2 X Slope (%)	N/A
			N/A	Ramp inside XWalk1?	N/A	N/A	Ramp inside XWalk2?	N/A
				Road Slope (%)	6.1	N/A	Clear Space?	N/A
				Road X Slope (%)	2.6	N/A	Clear Space to XWalk (in)	N/A
			N/A	Any Obstructions?	N/A	N/A	Storm Grate/Utility Hazard?	N/A
				Obstruction Type			Storm Grate/Utility Type	
					N/A			N/A
						Yes	Surface Condition? (G/P)	Good
Street 1 Name		KEMPTON PL						
Stop Condition-Street 2		StopSign						
Street 2 Name		N/A						
Stop Condition-Street 1		N/A						
Total Cost:		\$ 1850.00
