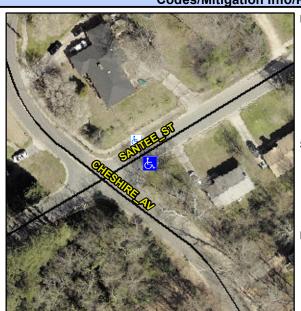
Total Cost:	\$	1850.00

Field Measurements/Component Compliance							
Comp	liance Description	Data	Comp	liance Description	Data		
N/A	Ramp Length (in)	72.0	Yes	Ramp Slope (%)	8.1		
No	Ramp Width (in)	47.5	Yes	Ramp XSlope (%)	1.4		
N/A	Flare Type LT	N/A	N/A	Flare Type RT	N/A		
N/A	Flare Slope LT (%)	N/A	N/A	Flare Slope RT (%)	N/A		
N/A	Flare Traversable LT?	N/A	N/A	Flare Traversable RT?	N/A		
N/A	Landing Length (in)	N/A	N/A	DWS Provided?	N/A		
N/A	Landing Width (in)	N/A	N/A	DWS Contrast?	N/A		
N/A	Landing Slope (%)	N/A	N/A	DWS Length (in)	N/A		
N/A	Landing X Slope (%)	N/A	N/A	DWS Full Width?	N/A		
N/A	Landing Curb? (Y/N)	N/A	N/A	DWS Offset (in)	N/A		
N/A	Shared Landing?	N/A					
N/A	Gutter Ponding?	N/A	N/A	Gutter Slope (%)	N/A		
N/A	Gutter Lip Ht (in)	N/A	N/A	Gutter X Slope (%)	N/A		
N/A	Painted X Walk1?	No	N/A	Painted X Walk2?	N/A		
	X Walk 1 Direction	To N		X Walk 2 Direction	N/A		
N/A	X Walk 1 Width (in)	N/A	N/A	X Walk 2 Width (in)	N/A

Street 1 Name
SANTEE ST
Stop Condition-Street 2
None
Street 2 Name
N/A
Stop Condition-Street 1
N/A
