Access Compliance Report

Public Rights-of-Way

(Curb Ramps)

Intersection ID: 31410	Main Street: BLACK_FOX_CT	Cross Street: OLD_WAGON_RD	Location: NE
ADA ID: 360F57B6275F	Ramp Type: PerpDiag	Initial Pass/Fail: Fail	Overall Compliance: No
Codes/Mitigation Info/Possible Solution		Field Measurements/Component Compliance	
Severity Score: 12.5

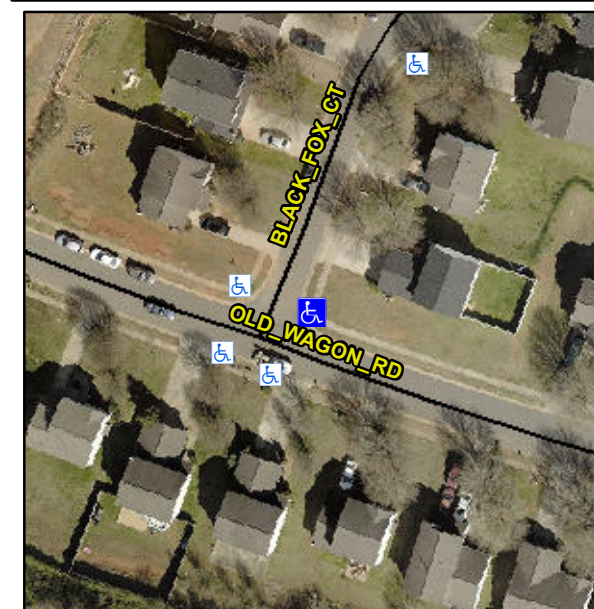
Not Found, R304.5.3

Compliance	Description	Data	Compliance	Description	Data
N/A	Ramp Length (in)	44.5	Yes	Ramp Slope (%)	5.5
Yes	Ramp Width (in)	48.0	No	Ramp XSlope (%)	6.0
N/A	Flare Type LT	N/A	N/A	Flare Type RT	N/A
N/A	Flare Slope LT (%)	N/A	N/A	Flare Slope RT (%)	N/A
N/A	Flare Traversable LT?	N/A	N/A	Flare Traversable RT?	N/A
N/A	Landing Length (in)	N/A	N/A	DWS Provided?	N/A
N/A	Landing Width (in)	N/A	N/A	DWS Contrast?	N/A
N/A	Landing Slope (%)	N/A	N/A	DWS Length (in)	N/A
N/A	Landing X Slope (%)	N/A	N/A	DWS Full Width?	N/A
N/A	Landing Curb? (Y/N)	N/A	N/A	DWS Offset (in)	N/A
N/A	Shared Landing?	N/A			
N/A	Gutter Ponding?	N/A	N/A	Gutter Slope (%)	N/A
N/A	Gutter Lip Ht (in)	1.0	N/A	Gutter X Slope (%)	N/A
N/A	Painted X Walk1?	No	N/A	Painted X Walk2?	No
	X Walk 1 Direction	To W		X Walk 2 Direction	To S
N/A	X Walk 1 Width (in)	N/A	N/A	X Walk 2 Width (in)	N/A
	X Walk 1 Slope (%)	6.1		X Walk 2 Slope (%)	3.5
	X Walk 1 X Slope (%)	1.2		X Walk 2 X Slope (%)	3.8

N/A	Ramp inside XWalk1?	N/A	N/A	Ramp inside XWalk2?	N/A
	Road Slope (%)	1.4	N/A	Clear Space?	N/A
	Road X Slope (%)	5.2	N/A	Clear Space to XWalk (in)	N/A
N/A	Any Obstructions?	N/A	N/A	Storm Grate/Utility Hazard?	N/A
	Obstruction Type			Storm Grate/Utility Type	
		N/A			N/A
			Yes	Surface Condition? (G/P)	Good

Remove & Replace Curb Ramp With Two New Directional Ramps or Equivalent.
