## **Access Compliance Report Public Rights-of-Way** (Curb Ramps)

Intersection ID: 45288 Main Street: ALLEGIANCE DR Cross Street: ANN\_MARIE\_DR Location: NW ADA ID: 3612DE05AD5E Ramp Type: PerpDiag Initial Pass/Fail: Fail **Overall Compliance: No** Severity Score: 46.25

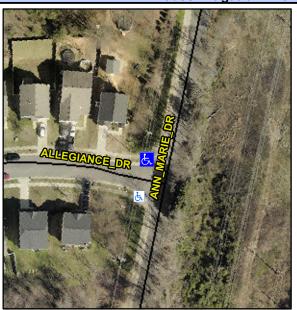
Field Measurements/Component Compliance						
	Compliance Description		Data	Comp	oliance Description	Data
	N/A	Ramp Length (in)	96.0	No	Ramp Slope (%)	10.6
	No	Ramp Width (in)	39.0	No	Ramp XSlope (%)	12.7
	N/A	Flare Type LT	N/A	N/A	Flare Type RT	N/A
	N/A	Flare Slope LT (%)	N/A	N/A	Flare Slope RT (%)	N/A
	N/A	Flare Traversable LT?	N/A	N/A	Flare Traversable RT?	N/A
	N/A	Landing Length (in)	N/A	N/A	DWS Provided?	N/A
	N/A	Landing Width (in)	N/A	N/A	DWS Contrast?	N/A
	N/A	Landing Slope (%)	N/A	N/A	DWS Length (in)	N/A
	N/A	Landing X Slope (%)	N/A	N/A	DWS Full Width?	N/A
	N/A	Landing Curb? (Y/N)	N/A	N/A	DWS Offset (in)	N/A
	N/A	Shared Landing?	N/A			
	N/A	Gutter Ponding?	N/A	N/A	Gutter Slope (%)	N/A
	N/A	Gutter Lip Ht (in)	N/A	N/A	Gutter X Slope (%)	N/A
	N/A	Painted X Walk1?	No	N/A	Painted X Walk2?	No
		X Walk 1 Direction	To SW		X Walk 2 Direction	To E
	N/A	X Walk 1 Width (in)	N/A	N/A	X Walk 2 Width (in)	N/A
		X Walk 1 Slope (%)	2.8		X Walk 2 Slope (%)	8.3

X Walk 1 X Slope (%)	6.6		X Walk 2 X Slope (%)	5.9
	N/A	Ramp inside XWalk1?	N/A	N/A	Ramp inside XWalk2?	N/A
		Road Slope (%)	9.3	N/A	Clear Space?	N/A
		Road X Slope (%)	2.2	N/A	Clear Space to XWalk (in)	N/A
	N/A	Any Obstructions?	N/A	N/A	Storm Grate/Utility Hazard?	N/A
		Obstruction Type			Storm Grate/Utility Type	
			N/A			N/A
				Yes	Surface Condition? (G/P)	Good
	A F C	The second second second

Possible Solutions: Remove & Replace Curb Ramp With **Two New Directional Ramps or** Equivalent. Surveyor Notes: N/A PROW/ADA: Not Found, R304.5.1, R304.2.2, R304.5.3
