# Access Compliance Report

## Public Rights-of-Way

| Intersection ID: 19746 | Main Street: PINEBURR_RD | Cross Street: THERMAL_RD | Location: | E |
| ADA ID: 3613F9A6BE3A | Ramp Type: PerpDiag | Initial Pass/Fail: Fail | Overall Compliance: No | Severity Score: 22.5 |

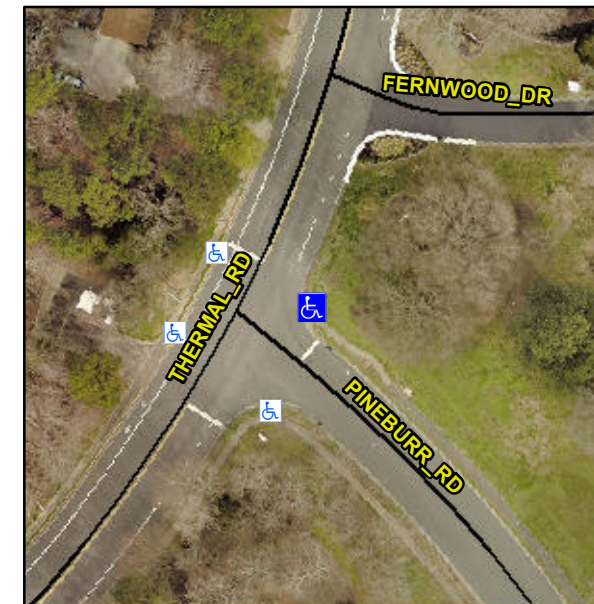
**R304.5.1, R304.2.2, R304.5.3**

| Compliance | Description | Data | Compliance | Description | Data |
|---|---|---|---|---|---|
| N/A | Ramp Length (in) | 32.0 | No | Ramp Slope (%) | 9.1 |
| No | Ramp Width (in) | 44.0 | No | Ramp XSlope (%) | 3.9 |

**Remove & Replace Curb Ramp With Two New Directional Ramps or Equivalent.**
