# Access Compliance Report

## Public Rights-of-Way

### (Curb Ramps)

Intersection ID: 2827	Main Street: DERVISH_LN	Cross Street: SWALLOW_TAIL_LN	Location: E
ADA ID: 3622EEA269D7	Ramp Type: PerpDiag	Initial Pass/Fail: Fail	Overall Compliance: No
Severity Score: 33.75			
Codes/Mitigation Info/Possible Solution		Field Measurements/Component Compliance

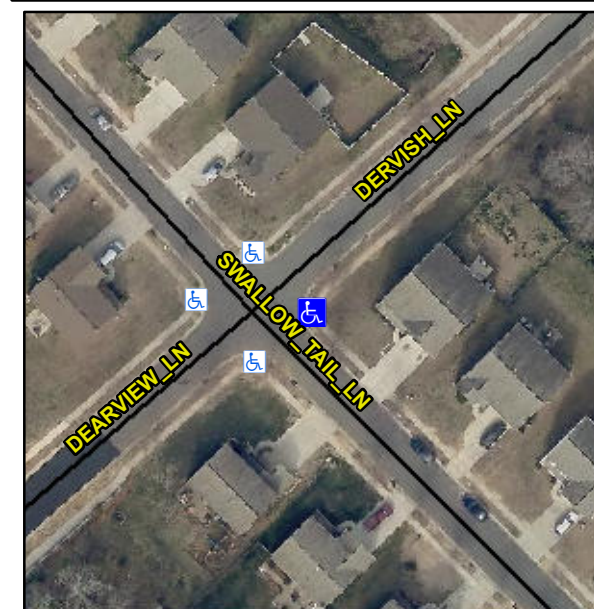
**Not Found, R304.5.1, R304.5.3**

Compliance	Description	Data	Compliance	Description	Data
N/A	Ramp Length (in)	48.0	Yes	Ramp Slope (%)	5.3
No	Ramp Width (in)	40.0	No	Ramp XSlope (%)	9.0
N/A	Flare Type LT	N/A	N/A	Flare Type RT	N/A
N/A	Flare Slope LT (%)	N/A	N/A	Flare Slope RT (%)	N/A
N/A	Flare Traversable LT?	N/A	N/A	Flare Traversable RT?	N/A
N/A	Landing Length (in)	N/A	N/A	DWS Provided?	N/A
N/A	Landing Width (in)	N/A	N/A	DWS Contrast?	N/A
N/A	Landing Slope (%)	N/A	N/A	DWS Length (in)	N/A
N/A	Landing X Slope (%)	N/A	N/A	DWS Full Width?	N/A
N/A	Landing Curb? (Y/N)	N/A	N/A	DWS Offset (in)	N/A
N/A	Shared Landing?	N/A			
N/A	Gutter Ponding?	N/A	N/A	Gutter Slope (%)	N/A
N/A	Gutter Lip Ht (in)	2.0	N/A	Gutter X Slope (%)	N/A
N/A	Painted X Walk1?	No	N/A	Painted X Walk2?	No
	X Walk 1 Direction	To NW		X Walk 2 Direction	To SW
N/A	X Walk 1 Width (in)	N/A	N/A	X Walk 2 Width (in)	N/A
	X Walk 1 Slope (%)	3.2		X Walk 2 Slope (%)	7.8
	X Walk 1 X Slope (%)	4.5		X Walk 2 X Slope (%)	2.0

N/A	Ramp inside XWalk1?	N/A	N/A	Ramp inside XWalk2?	N/A
	Road Slope (%)	6.7	N/A	Clear Space?	N/A
	Road X Slope (%)	4.4	N/A	Clear Space to XWalk (in)	N/A
N/A	Any Obstructions?	N/A	N/A	Storm Grate/Utility Hazard?	N/A
	Obstruction Type			Storm Grate/Utility Type	
		N/A			N/A
			Yes	Surface Condition? (G/P)	Good

**Remove & Replace Curb Ramp With Two New Directional Ramps or Equivalent.**
