## **Access Compliance Report Public Rights-of-Way** (Curb Ramps)

Intersection ID: 42714 Main Street: ARBORETUM\_DR **Cross Street: PROVIDENCE\_RD** Location: NE **Overall Compliance: No** ADA ID: 36272F4FD143 Ramp Type: MedianPerp Initial Pass/Fail: Fail Severity Score: 13.75

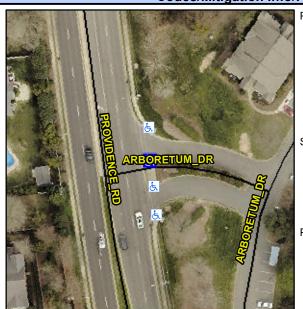
| Possible Solutions: | <u>c</u> |
|---|---|
| Not Found, R304.2.2, R304.5.3 | N |

| | Field Measurements/Component Compliance | | | | | | | | |
|---|---|---|---|---|---|---|--|--|--|
| | N/A | Ramp Length (in) | 46.5 | No | Ramp Slope (%) | 9.3 | | | |
| | Yes | Ramp Width (in) | 48.0 | No | Ramp XSlope (%) | 3.5 | | | |

| Possible Solutions: | <u>c</u> |
|---|---|
| Remove & Replace Entire Ramp. | N |
