# Access Compliance Report

## Public Rights-of-Way

### (Curb Ramps)

Intersection ID: 13855	Main Street: E_MOREHEAD_ST	Cross Street: ORIOLE_AV	Location: W
ADA ID: 3629FC220532	Ramp Type: Directional1	Initial Pass/Fail: Fail	Overall Compliance: No
Codes/Mitigation Info/Possible Solution		Field Measurements/Component Compliance	
Severity Score: 13.75

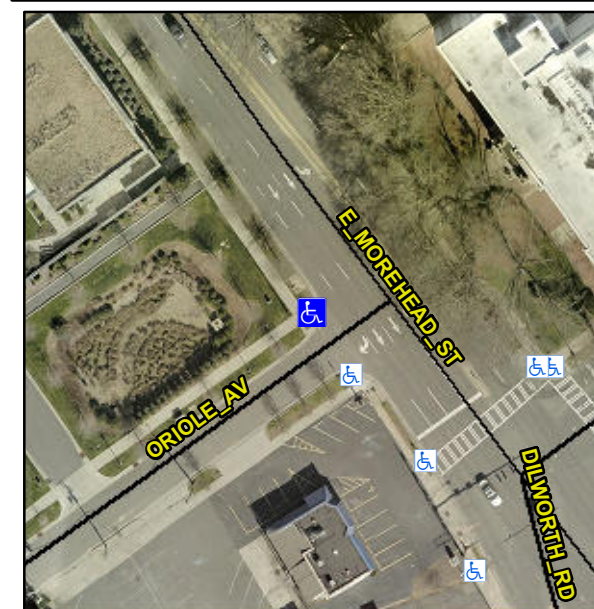
Compliance	Description	Data	Compliance	Description	Data
N/A	Ramp Length (in)	52.0	N/A	Grade Break?	N/A
Yes	Ramp Width (in)	69.0	N/A	Grade Break Slope (%)	0.0
No	Ramp Slope (%)	9.6	N/A	Grade Break XSlope (%)	0.0
No	Ramp XSlope (%)	2.1			
N/A	Flare Type LT	N/A	N/A	Flare Type RT	N/A
N/A	Flare Slope LT (%)	N/A	N/A	Flare Slope RT (%)	0.0
N/A	Flare Traversable LT?	N/A	N/A	Flare Traversable RT?	N/A
N/A	Landing Length (in)	0.0	N/A	DWS Provided?	N/A
N/A	Landing Width (in)	0.0	N/A	DWS Contrast?	N/A
N/A	Landing Slope (%)	0.0	N/A	DWS Length (in)	N/A
N/A	Landing X Slope (%)	0.0	N/A	DWS Full Width?	N/A
N/A	Landing Curb? (Y/N)	N/A	N/A	DWS Offset LT (in)	N/A
N/A	Shared Landing?	N/A	N/A	DWS Offset RT (in)	N/A
N/A	Gutter Ponding?	0.0	N/A	Gutter Slope (%)	N/A
N/A	Gutter Lip Ht (in)	0.0	N/A	Gutter X Slope (%)	N/A
N/A	Painted X Walk1?	No		Road Slope (%)	2.5
	X Walk 1 Direction	To SE		Road X Slope (%)	1.6
	X Walk 1 Width (in)	N/A		Clear Space?	N/A

X Walk 1 Slope (%)	2.5	N/A	Clear Space to XWalk (in)	N/A
	X Walk 1 X Slope (%)	1.6	N/A	Storm Grate/Utility Hazard?	N/A
N/A	Ramp inside XWalk1?	N/A		Storm Grate/Utility Type	
N/A	Any Obstructions?	N/A			N/A
	Obstruction Type		Yes	Surface Condition? (G/P)	Good
			N/A	Curb Slope (%)	8.4

**Remove & Replace Entire Ramp.**

**R304.2.2, R304.5.3**

\$ 1600.00
