Access Compliance Report Public Rights-of-Way (Curb Ramps)

Intersection ID: 52600Main Street:MCCULLOUGH_DRCross Street:IKEA_BVLocation:WADA ID: 363F68E50AB9Ramp Type:PerpInitial Pass/Fail:FailOverall Compliance:NoSeverity Score:8.75

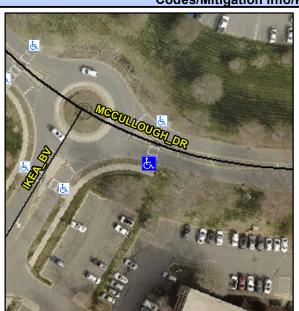
71.5 Yes

Ramp Slope (%)

No	Ramp Width (in)	47.5	Yes	Ramp XSlope (%)	1.7
N/A	Flare Type LT	N/A	N/A	Flare Type RT	N/A
N/A	Flare Slope LT (%)	N/A	N/A	Flare Slope RT (%)	N/A
N/A	Flare Traversable LT?	N/A	N/A	Flare Traversable RT?	N/A
N/A	Landing Length (in)	N/A	N/A	DWS Provided?	N/A
N/A	Landing Width (in)	N/A	N/A	DWS Contrast?	N/A
N/A	Landing Slope (%)	N/A	N/A	DWS Length (in)	N/A
N/A	Landing X Slope (%)	N/A	N/A	A DWS Full Width?	
N/A	Landing Curb? (Y/N)	N/A	N/A	DWS Offset (in)	
N/A	Shared Landing?	N/A			
N/A	Gutter Ponding?	N/A	N/A	Gutter Slope (%)	N/A
N/A	Gutter Lip Ht (in)	N/A	N/A	Gutter X Slope (%)	N/A
N/A	Painted X Walk1?	Yes	N/A	Painted X Walk2?	N/A
	X Walk 1 Direction	To NE		X Walk 2 Direction	N/A
N/A	X Walk 1 Width (in)	112.0	N/A	X Walk 2 Width (in)	N/A
	X Walk 1 Slope (%)	2.7		X Walk 2 Slope (%)	N/A
	X Walk 1 X Slope (%)	3.6		X Walk 2 X Slope (%)	N/A
N/A	Ramp inside XWalk1?	Yes	N/A	Ramp inside XWalk2?	N/A
	Road Slope (%)	N/A	N/A	Clear Space?	N/A

Road X Slope (%)	N/A	N/A	Clear Space to XWalk (in)	N/A
N/A	Any Obstructions?	N/A	N/A	Storm Grate/Utility Hazard?	N/A
	Obstruction Type			Storm Grate/Utility Type	
		N/A			N/A
			Yes	Surface Condition? (G/P)	Good
	To the state of th

1 099IDIE OOIGHOH						
Possible Solutions:						
Remove & Replace Entire Ramp.						
Cumunuar Natan						
Surveyor Notes:						
N/A						
DDOW/ADA						
PROW/ADA:						
Not Found, R304.5.1

Not Found					
ì	Not Found,	R304.5.1				
8						
1						
_						
	Total Cost:		\$	1850.00		
	10101 0001.		Ψ
