# Access Compliance Report

## Public Rights-of-Way

### (Curb Ramps)

Intersection ID: 13359	Main Street: BARRINGER_DR	Cross Street: S_I-77_RA	Location: SW
ADA ID: 364409956409	Ramp Type: ParaDiag	Initial Pass/Fail: Fail	Overall Compliance: No
		Severity Score: 12.5

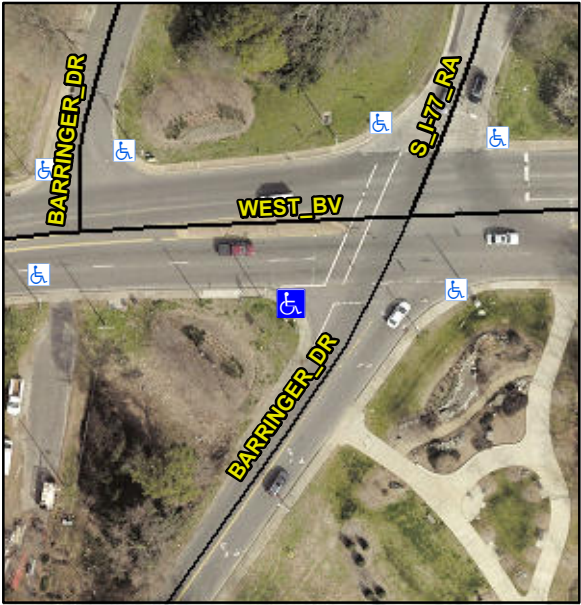
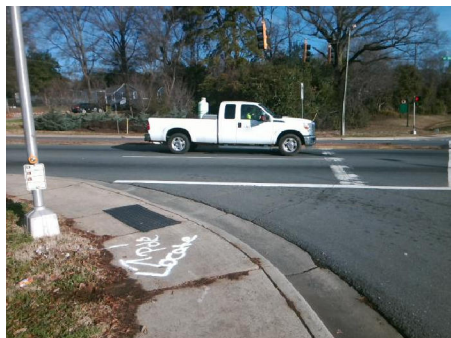
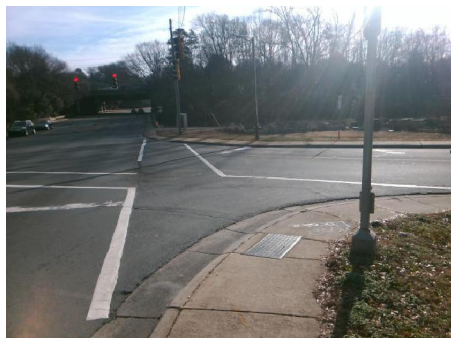
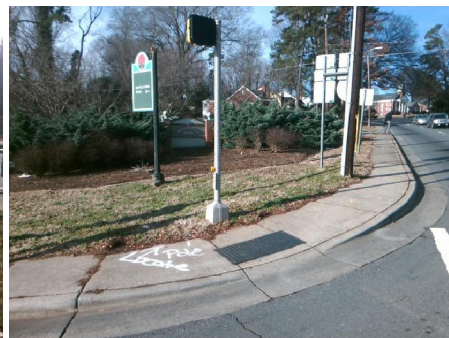
Compliance	Description	Data	Compliance	Description	Data
N/A	Ramp Length LT (in)	57.0	N/A	Ramp Length RT (in)	63.0
Yes	Ramp Width LT (in)	61.0	Yes	Ramp Width RT (in)	59.0
Yes	Ramp Slope LT (%)	7.9	No	Ramp Slope RT (%)	11.8
Yes	Ramp XSlope LT (%)	1.6	Yes	Ramp XSlope RT (%)	1.8
N/A	Landing Length (in)	N/A	N/A	DWS Provided?	N/A
N/A	Landing Width (in)	N/A	N/A	DWS Contrast?	N/A
N/A	Landing Slope (%)	N/A	N/A	DWS Length (in)	N/A
N/A	Landing X Slope (%)	N/A	N/A	DWS Full Width?	N/A
N/A	Landing Curb? (Y/N)	N/A	N/A	DWS Offset (in)	N/A
N/A	Shared Landing?	N/A			
N/A	Gutter Ponding?	N/A	N/A	Gutter Slope (%)	N/A
N/A	Gutter Lip Ht (in)	N/A	N/A	Gutter X Slope (%)	N/A
N/A	Painted X Walk1?	Yes	N/A	Painted X Walk2?	Yes
	X Walk 1 Direction	To E		X Walk 2 Direction	To NE
N/A	X Walk 1 Width (in)	109.0	N/A	X Walk 2 Width (in)	110.0
	X Walk 1 Slope (%)	1.3		X Walk 2 Slope (%)	0.8
	X Walk 1 X Slope (%)	3.9		X Walk 2 X Slope (%)	5.6

N/A	Ramp inside XWalk1?	Yes	N/A	Ramp inside XWalk2?	Yes
	Road Slope (%)	8.0	N/A	Clear Space?	N/A
	Road X Slope (%)	1.6	N/A	Clear Space to XWalk (in)	N/A
N/A	Any Obstructions?	N/A	N/A	Storm Grate/Utility Hazard?	N/A
	Obstruction Type			Storm Grate/Utility Type	
		N/A			N/A
			Yes	Surface Condition? (G/P)	Good
			N/A	Curb Slope (%)	15.4

Possible Solutions:				
	Remove & Replace Curb Ramp With Two New Directional Ramps or Equivalent.				
	Surveyor Notes:				
	N/A				
	PROW/ADA:				
	R304.3.2				
Street 1 Name	BARRINGER DR				
Stop Condition-Street 1	Signal				
Street 2 Name	WEST BV				
Stop Condition-Street 2	Signal				
Total Cost:		\$	3200.00
