Access Compliance Report

Public Rights-of-Way

(Curb Ramps)

| Intersection ID: 53160 | Main Street: PERTH_MOOR_RD | Cross Street: HAMILTON_BRIDGE_RD | Location: SW |

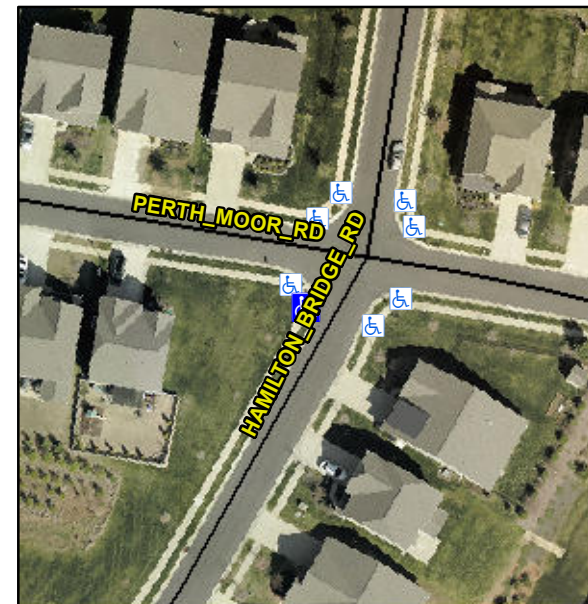
| ADA ID: 36445841E355 | Ramp Type: Perp | Initial Pass/Fail: Fail | Overall Compliance: No |

R304.2.2

| Compliance | Description | Data | Compliance | Description | Data |
|---|---|---|---|---|---|
| N/A | Ramp Length (in) | 48.0 | No | Ramp Slope (%) | 8.6 |

Remove & Replace Entire Ramp.
