Access Compliance Report

Public Rights-of-Way

(Curb Ramps)

Intersection ID: 11425	Main Street: AVENING_CT	Cross Street: AVENSONG_CROSSING_DR	Location: SW
ADA ID: 36470D3818CB	Ramp Type: Perp	Initial Pass/Fail: Fail	Overall Compliance: No
Severity Score: 8.75			
Codes/Mitigation Info/Possible Solution		Field Measurements/Component Compliance

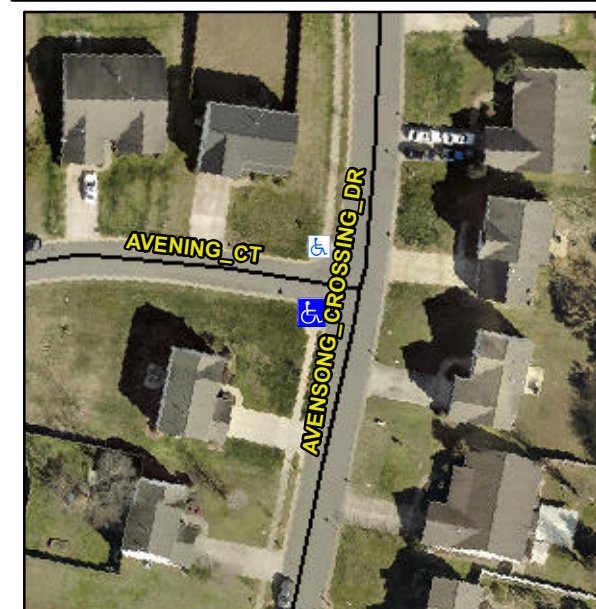
Not Found, R304.5.1

Compliance	Description	Data	Compliance	Description	Data
N/A	Ramp Length (in)	48.5	Yes	Ramp Slope (%)	5.3
No	Ramp Width (in)	45.5	Yes	Ramp XSlope (%)	0.7
N/A	Flare Type LT	N/A	N/A	Flare Type RT	N/A
N/A	Flare Slope LT (%)	N/A	N/A	Flare Slope RT (%)	N/A
N/A	Flare Traversable LT?	N/A	N/A	Flare Traversable RT?	N/A
N/A	Landing Length (in)	N/A	N/A	DWS Provided?	N/A
N/A	Landing Width (in)	N/A	N/A	DWS Contrast?	N/A
N/A	Landing Slope (%)	N/A	N/A	DWS Length (in)	N/A
N/A	Landing X Slope (%)	N/A	N/A	DWS Full Width?	N/A
N/A	Landing Curb? (Y/N)	N/A	N/A	DWS Offset (in)	N/A
N/A	Shared Landing?	N/A			
N/A	Gutter Ponding?	N/A	N/A	Gutter Slope (%)	N/A
N/A	Gutter Lip Ht (in)	N/A	N/A	Gutter X Slope (%)	N/A
N/A	Painted X Walk1?	No	N/A	Painted X Walk2?	N/A
	X Walk 1 Direction	To N		X Walk 2 Direction	N/A
N/A	X Walk 1 Width (in)	N/A	N/A	X Walk 2 Width (in)	N/A
	X Walk 1 Slope (%)	0.2		X Walk 2 Slope (%)	N/A
	X Walk 1 X Slope (%)	3.1		X Walk 2 X Slope (%)	N/A

N/A	Ramp inside XWalk1?	N/A	N/A	Ramp inside XWalk2?	N/A
	Road Slope (%)	N/A	N/A	Clear Space?	N/A
	Road X Slope (%)	N/A	N/A	Clear Space to XWalk (in)	N/A
N/A	Any Obstructions?	N/A	N/A	Storm Grate/Utility Hazard?	N/A
	Obstruction Type			Storm Grate/Utility Type	
		N/A			N/A
			Yes	Surface Condition? (G/P)	Good

Remove & Replace Entire Ramp.
