Access Compliance Report

Public Rights-of-Way (Curb Ramps)

Intersection ID: 6358	Main Street: BLACK_TRAIL_CT	Cross Street: MILHAVEN_LN	Location: SW
ADA ID: 368D6FB8EE1C	Ramp Type: Directional1	Initial Pass/Fail: Fail	Overall Compliance: No
			Severity Score: 13.75

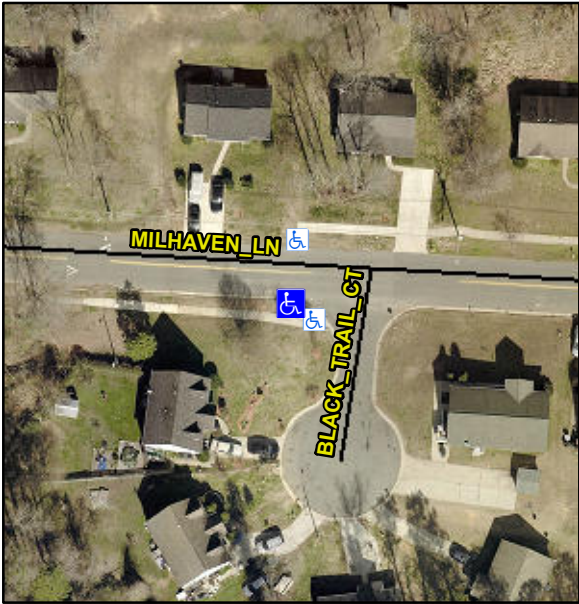
Possible Solutions:		Compliance			Description			Data	
	Remove & Replace Entire Ramp.		N/A	Ramp Length (in)	77.0	N/A	Grade Break?	N/A		
			Yes	Ramp Width (in)	57.0	N/A	Grade Break Slope (%)	0.0		
			No	Ramp Slope (%)	9.2	N/A	Grade Break XSlope (%)	0.0		
			No	Ramp XSlope (%)	2.3					
			N/A	Flare Type LT	N/A	N/A	Flare Type RT	N/A		
			N/A	Flare Slope LT (%)	N/A	N/A	Flare Slope RT (%)	0.0		
			N/A	Flare Traversable LT?	N/A	N/A	Flare Traversable RT?	N/A		
			N/A	Landing Length (in)	0.0	N/A	DWS Provided?	N/A		
			N/A	Landing Width (in)	0.0	N/A	DWS Contrast?	N/A		
		N/A	Landing Slope (%)	0.0	N/A	DWS Length (in)	N/A			
		N/A	Landing X Slope (%)	0.0	N/A	DWS Full Width?	N/A			
		N/A	Landing Curb? (Y/N)	N/A	N/A	DWS Offset LT (in)	N/A			
		N/A	Shared Landing?	N/A	N/A	DWS Offset RT (in)	N/A			
		N/A	Gutter Ponding?	0.0	N/A	Gutter Slope (%)	N/A

N/A	Gutter Lip Ht (in)	0.0	N/A	Gutter X Slope (%)	N/A			
		N/A	Painted X Walk1?	No		Road Slope (%)	7.7			
			X Walk 1 Direction	To N		Road X Slope (%)	2.0			
			X Walk 1 Width (in)	N/A		Clear Space?	N/A			
			X Walk 1 Slope (%)	7.7	N/A	Clear Space to XWalk (in)	N/A			
			X Walk 1 X Slope (%)	2.0	N/A	Storm Grate/Utility Hazard?	N/A			
		N/A	Ramp inside XWalk1?	N/A		Storm Grate/Utility Type				
		N/A	Any Obstructions?	N/A			N/A			
			Obstruction Type		Yes	Surface Condition? (G/P)	Good			
					N/A	Curb Slope (%)	N/A			
Total Cost:		\$	1600.00							
Street 1 Name		MILHAVEN LN								
Stop Condition-Street 1		None								
Street 2 Name		N/A								
Stop Condition-Street 2		N/A
