Access Compliance Report

Public Rights-of-Way

(Curb Ramps)

Intersection ID: N/A	Main Street: BROOKVALE_ST	Cross Street: HORACE_ST	Location: E
ADA ID: 36933D6B0928	Ramp Type: Perp	Initial Pass/Fail: Fail	Overall Compliance: No
Severity Score: 13.75			
Codes/Mitigation Info/Possible Solution		Field Measurements/Component Compliance

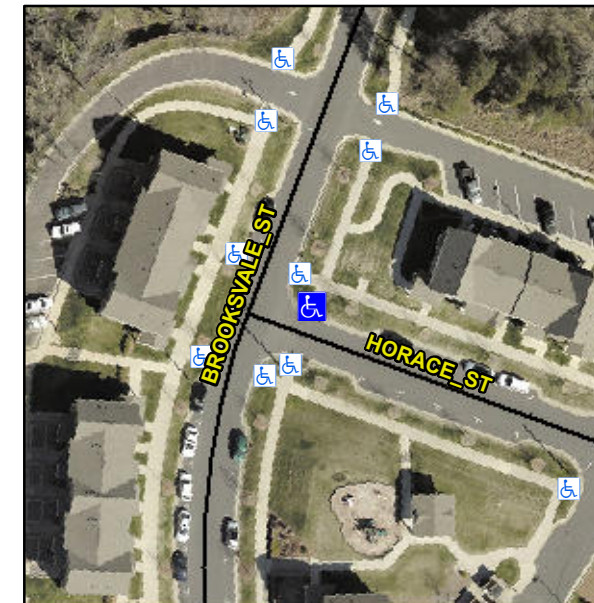
Not Found, R304.2.2, R304.5.3

Compliance	Description	Data	Compliance	Description	Data
N/A	Ramp Length (in)	72.0	No	Ramp Slope (%)	9.2
Yes	Ramp Width (in)	70.0	No	Ramp XSlope (%)	2.2
N/A	Flare Type LT	N/A	N/A	Flare Type RT	N/A
N/A	Flare Slope LT (%)	N/A	N/A	Flare Slope RT (%)	N/A
N/A	Flare Traversable LT?	N/A	N/A	Flare Traversable RT?	N/A
N/A	Landing Length (in)	N/A	N/A	DWS Provided?	N/A
N/A	Landing Width (in)	N/A	N/A	DWS Contrast?	N/A
N/A	Landing Slope (%)	N/A	N/A	DWS Length (in)	N/A
N/A	Landing X Slope (%)	N/A	N/A	DWS Full Width?	N/A
N/A	Landing Curb? (Y/N)	N/A	N/A	DWS Offset (in)	N/A
N/A	Shared Landing?	N/A			
N/A	Gutter Ponding?	N/A	N/A	Gutter Slope (%)	N/A
N/A	Gutter Lip Ht (in)	N/A	N/A	Gutter X Slope (%)	N/A
N/A	Painted X Walk1?	No	N/A	Painted X Walk2?	N/A
	X Walk 1 Direction	To SW		X Walk 2 Direction	N/A
N/A	X Walk 1 Width (in)	N/A	N/A	X Walk 2 Width (in)	N/A
	X Walk 1 Slope (%)	2.0		X Walk 2 Slope (%)	N/A
	X Walk 1 X Slope (%)	2.9		X Walk 2 X Slope (%)	N/A

N/A	Ramp inside XWalk1?	N/A	N/A	Ramp inside XWalk2?	N/A
	Road Slope (%)	N/A	N/A	Clear Space?	N/A
	Road X Slope (%)	N/A	N/A	Clear Space to XWalk (in)	N/A
N/A	Any Obstructions?	N/A	N/A	Storm Grate/Utility Hazard?	N/A
	Obstruction Type			Storm Grate/Utility Type	
		N/A			N/A
			Yes	Surface Condition? (G/P)	Good

Possible Solutions:

Remove & Replace Entire Ramp.
