# Access Compliance Report

## Public Rights-of-Way

### (Curb Ramps)

Intersection ID: 9178	Main Street: BEATTIES_FORD_RD	Cross Street: TATE_ST	Location: SW
ADA ID: 3697DE893035	Ramp Type: PerpDiag	Initial Pass/Fail: Fail	Overall Compliance: No
		Severity Score: 30

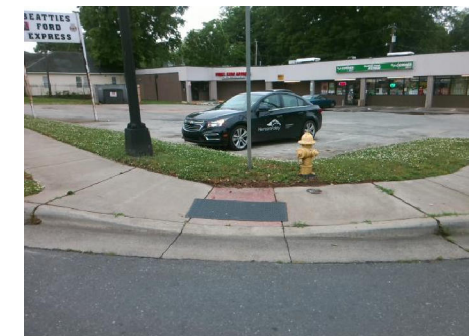
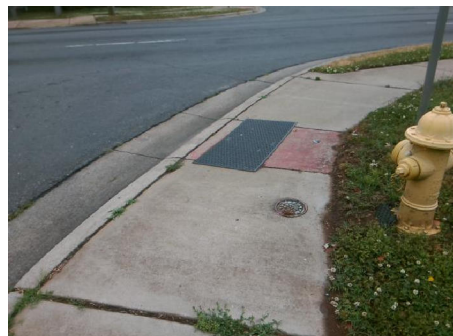
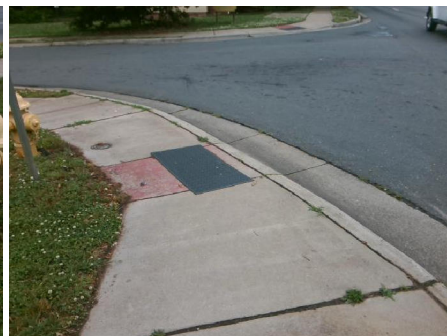
**Not Found, R304.5.1, R304.5.3**

Compliance	Description	Data	Compliance	Description	Data
N/A	Ramp Length (in)	59.0	Yes	Ramp Slope (%)	6.5
No	Ramp Width (in)	35.5	No	Ramp XSlope (%)	5.5
N/A	Flare Type LT	N/A	N/A	Flare Type RT	N/A
N/A	Flare Slope LT (%)	N/A	N/A	Flare Slope RT (%)	N/A
N/A	Flare Traversable LT?	N/A	N/A	Flare Traversable RT?	N/A
N/A	Landing Length (in)	N/A	N/A	DWS Provided?	N/A
N/A	Landing Width (in)	N/A	N/A	DWS Contrast?	N/A
N/A	Landing Slope (%)	N/A	N/A	DWS Length (in)	N/A
N/A	Landing X Slope (%)	N/A	N/A	DWS Full Width?	N/A
N/A	Landing Curb? (Y/N)	N/A	N/A	DWS Offset (in)	N/A
N/A	Shared Landing?	N/A			
N/A	Gutter Ponding?	N/A	N/A	Gutter Slope (%)	N/A
N/A	Gutter Lip Ht (in)	N/A	N/A	Gutter X Slope (%)	N/A
N/A	Painted X Walk1?	No	N/A	Painted X Walk2?	No
	X Walk 1 Direction	To E		X Walk 2 Direction	To N
N/A	X Walk 1 Width (in)	N/A	N/A	X Walk 2 Width (in)	N/A
	X Walk 1 Slope (%)	1.7		X Walk 2 Slope (%)	1.3
	X Walk 1 X Slope (%)	0.5		X Walk 2 X Slope (%)	4.3

N/A	Ramp inside XWalk1?	N/A	N/A	Ramp inside XWalk2?	N/A
	Road Slope (%)	4.0	N/A	Clear Space?	N/A
	Road X Slope (%)	6.3	N/A	Clear Space to XWalk (in)	N/A
N/A	Any Obstructions?	N/A	N/A	Storm Grate/Utility Hazard?	N/A
	Obstruction Type			Storm Grate/Utility Type	
		N/A			N/A
		Yes		Surface Condition? (G/P)	Good

**Remove & Replace Curb Ramp With Two New Directional Ramps or Equivalent.**
