# Access Compliance Report Public Rights-of-Way (Curb Ramps)

Intersection ID: 43656      Main Street: HUNTINGTON\_MEADOW\_LN      Cross Street: CALLOW\_FOREST\_DR      Location: NW

ADA ID: 36A52E57A968      Ramp Type: PerpDiag      Initial Pass/Fail: Pass      Overall Compliance: No      Severity Score: 15

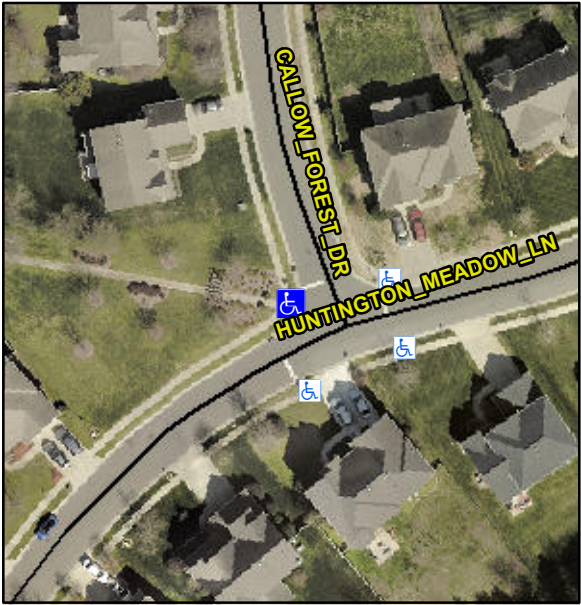
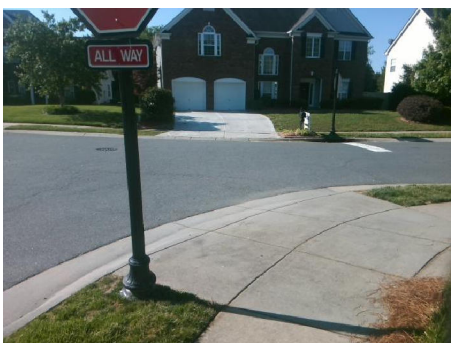
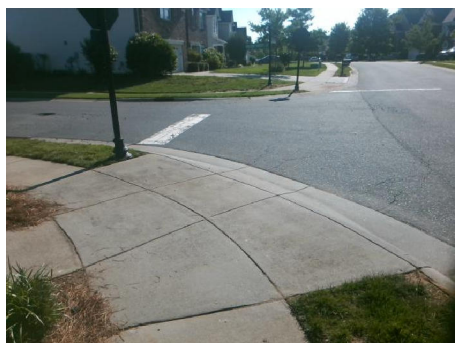
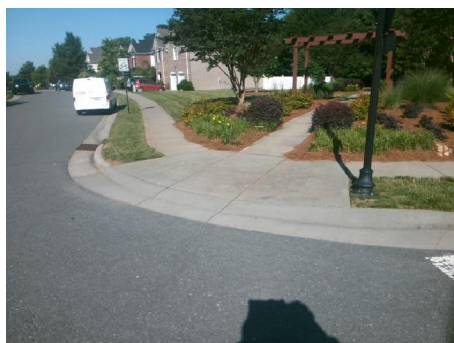
PROW/ADA:  
**Not Found, R304.2.2-Perp, R304.3.2-Para, R305, R304.5.4**

Compliance	Description	Data	Compliance	Description	Data
N/A	Ramp Length (in)	48.0	Yes	Ramp Slope (%)	6.9
Yes	Ramp Width (in)	49.0	Yes	Ramp XSlope (%)	1.0
N/A	Flare Type LT	Sloped	N/A	Flare Type RT	N/A
N/A	Flare Slope LT (%)	1.5	N/A	Flare Slope RT (%)	6.4
N/A	Flare Traversable LT?	No	N/A	Flare Traversable RT?	No
Yes	Landing Length (in)	49.0	No	DWS Provided?	No
Yes	Landing Width (in)	48.0	N/A	DWS Contrast?	No
No	Landing Slope (%)	2.3	N/A	DWS Length (in)	N/A
Yes	Landing X Slope (%)	1.6	N/A	DWS Full Width?	No
N/A	Landing Curb? (Y/N)	No	N/A	DWS Offset (in)	N/A
N/A	Shared Landing?	No			
Yes	Gutter Ponding?	No	No	Gutter Slope (%)	5.6
Yes	Gutter Lip Ht (in)	0.0	Yes	Gutter X Slope (%)	1.7
N/A	Painted X Walk1?	No	N/A	Painted X Walk2?	No
	X Walk 1 Direction	To S		X Walk 2 Direction	To E
N/A	X Walk 1 Width (in)	N/A	N/A	X Walk 2 Width (in)	N/A
	X Walk 1 Slope (%)	2.4		X Walk 2 Slope (%)	3.4
	X Walk 1 X Slope (%)	3.0		X Walk 2 X Slope (%)	1.8

N/A	Ramp inside XWalk1?	N/A	N/A	Ramp inside XWalk2?	N/A
	Road Slope (%)	2.0	N/A	Clear Space?	Yes
	Road X Slope (%)	6.6	N/A	Clear Space to XWalk (in)	N/A
Yes	Any Obstructions?	No	Yes	Storm Grate/Utility Hazard?	No
	Obstruction Type			Storm Grate/Utility Type	
			N/A		N/A
			Yes	Surface Condition? (G/P)	Good

Possible Solutions:  
**Remove & Replace Curb Ramp With Two New Directional Ramps or Equivalent. Remove & Replace Gutter.**
