Access Compliance Report

Public Rights-of-Way

(Curb Ramps)

Intersection ID: 12278	Main Street: SEIGLE_AV	Cross Street: VAN_EVERY_ST	Location: S
ADA ID: 36A959C1CE18	Ramp Type: PerpDiag	Initial Pass/Fail: Fail	Overall Compliance: No
		Severity Score: 25

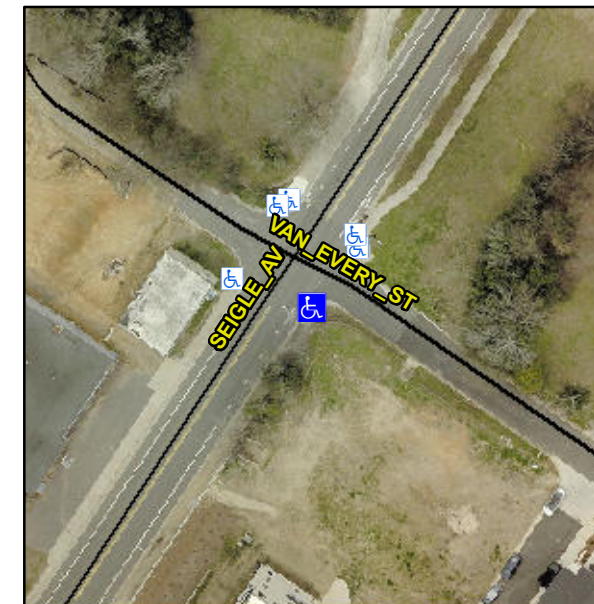
Not Found, R304.5.3

Compliance	Description	Data	Compliance	Description	Data
N/A	Ramp Length (in)	40.0	Yes	Ramp Slope (%)	5.3
Yes	Ramp Width (in)	48.0	No	Ramp XSlope (%)	7.2
N/A	Flare Type LT	N/A	N/A	Flare Type RT	N/A
N/A	Flare Slope LT (%)	N/A	N/A	Flare Slope RT (%)	N/A
N/A	Flare Traversable LT?	N/A	N/A	Flare Traversable RT?	N/A
N/A	Landing Length (in)	N/A	N/A	DWS Provided?	N/A
N/A	Landing Width (in)	N/A	N/A	DWS Contrast?	N/A
N/A	Landing Slope (%)	N/A	N/A	DWS Length (in)	N/A
N/A	Landing X Slope (%)	N/A	N/A	DWS Full Width?	N/A
N/A	Landing Curb? (Y/N)	N/A	N/A	DWS Offset (in)	N/A
N/A	Shared Landing?	N/A			
N/A	Gutter Ponding?	N/A	N/A	Gutter Slope (%)	N/A
N/A	Gutter Lip Ht (in)	N/A	N/A	Gutter X Slope (%)	N/A
N/A	Painted X Walk1?	No	N/A	Painted X Walk2?	No
	X Walk 1 Direction	To NE		X Walk 2 Direction	To NW
N/A	X Walk 1 Width (in)	N/A	N/A	X Walk 2 Width (in)	N/A
	X Walk 1 Slope (%)	9.1		X Walk 2 Slope (%)	3.1
	X Walk 1 X Slope (%)	1.7		X Walk 2 X Slope (%)	6.9

N/A	Ramp inside XWalk1?	N/A	N/A	Ramp inside XWalk2?	N/A
	Road Slope (%)	7.8	N/A	Clear Space?	N/A
	Road X Slope (%)	4.1	N/A	Clear Space to XWalk (in)	N/A
N/A	Any Obstructions?	N/A	N/A	Storm Grate/Utility Hazard?	N/A
	Obstruction Type			Storm Grate/Utility Type	
		N/A			N/A
			Yes	Surface Condition? (G/P)	Good

Remove & Replace Curb Ramp With Two New Directional Ramps or Equivalent.

Total Cost: \$ 3200.00
