# Access Compliance Report

## Public Rights-of-Way

| Intersection ID: N/A | Main Street: RED_RUST_LN | Cross Street: COYOTE_LN | Location: NE |
| ADA ID: 36B8783ABF0D | Ramp Type: PerpDiag | Initial Pass/Fail: Fail | Overall Compliance: No |

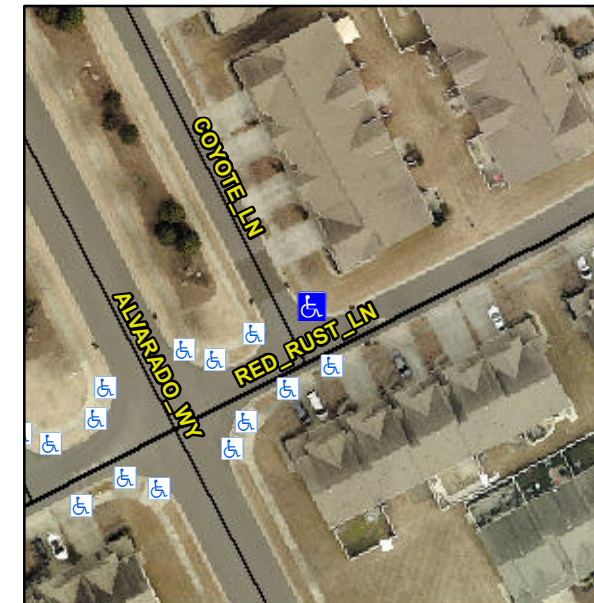
**R304.5.1**

| Compliance | Description | Data | Compliance | Description | Data |
|---|---|---|---|---|---|
| No | Ramp Width (in) | 46.5 | Yes | Ramp XSlope (%) | 0.2 |

**Remove & Replace Curb Ramp With Two New Directional Ramps or Equivalent.**
