Intersection ID: 21686	Main Street: BROOKFIELD_DR	Cross Street: SHARON_RD	Location:	SW
ADA ID: 36B92CAB496A	Ramp Type: PerpDiag	Initial Pass/Fail: Fail	Overall Compliance: No	Severity Score: 25

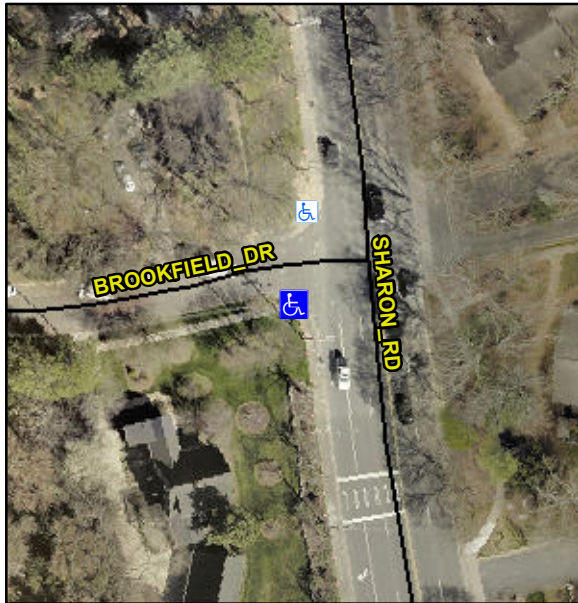
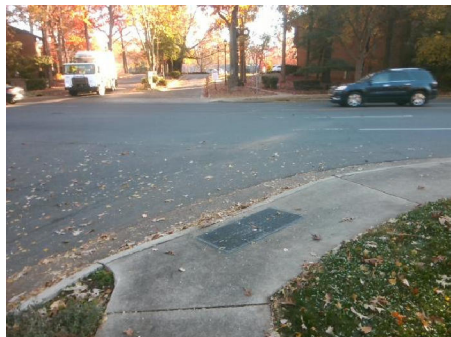
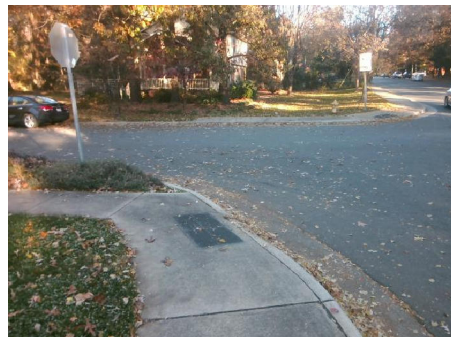
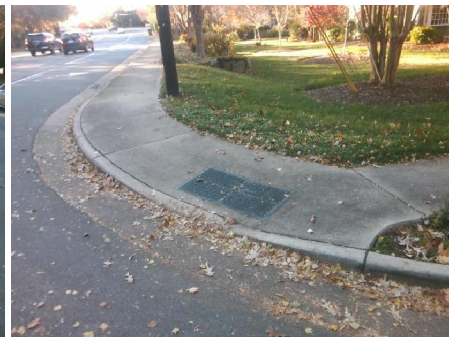
Not Found, R304.2.2, R304.5.3

Compliance	Description	Data	Compliance	Description	Data
N/A	Ramp Length (in)	60.0	No	Ramp Slope (%)	10.1
Yes	Ramp Width (in)	48.0	No	Ramp XSlope (%)	5.4
N/A	Flare Type LT	N/A	N/A	Flare Type RT	N/A
N/A	Flare Slope LT (%)	N/A	N/A	Flare Slope RT (%)	N/A
N/A	Flare Traversable LT?	N/A	N/A	Flare Traversable RT?	N/A
N/A	Landing Length (in)	N/A	N/A	DWS Provided?	N/A
N/A	Landing Width (in)	N/A	N/A	DWS Contrast?	N/A
N/A	Landing Slope (%)	N/A	N/A	DWS Length (in)	N/A
N/A	Landing X Slope (%)	N/A	N/A	DWS Full Width?	N/A
N/A	Landing Curb? (Y/N)	N/A	N/A	DWS Offset (in)	N/A
N/A	Shared Landing?	N/A			
N/A	Gutter Ponding?	N/A	N/A	Gutter Slope (%)	N/A
N/A	Gutter Lip Ht (in)	N/A	N/A	Gutter X Slope (%)	N/A
N/A	Painted X Walk1?	No	N/A	Painted X Walk2?	No
	X Walk 1 Direction	To E		X Walk 2 Direction	To N
N/A	X Walk 1 Width (in)	N/A	N/A	X Walk 2 Width (in)	N/A
	X Walk 1 Slope (%)	5.2		X Walk 2 Slope (%)	3.8
	X Walk 1 X Slope (%)	0.1		X Walk 2 X Slope (%)	5.5

N/A	Ramp inside XWalk1?	N/A	N/A	Ramp inside XWalk2?	N/A
	Road Slope (%)	3.5	N/A	Clear Space?	N/A
	Road X Slope (%)	5.5	N/A	Clear Space to XWalk (in)	N/A
N/A	Any Obstructions?	N/A	N/A	Storm Grate/Utility Hazard?	N/A
	Obstruction Type			Storm Grate/Utility Type	
		N/A			N/A
			Yes	Surface Condition? (G/P)	Good

Remove & Replace Curb Ramp With Two New Directional Ramps or Equivalent.
