# Access Compliance Report

## Public Rights-of-Way

### (Curb Ramps)

Intersection ID: 8226	Main Street: CATHERINE_SIMMONS_AV	Cross Street: CUSTER_ST	Location: NE
ADA ID: 36C087FA44FB	Ramp Type: PerpDiag	Initial Pass/Fail: Fail	Overall Compliance: No
Severity Score: 12.5			
Codes/Mitigation Info/Possible Solution		Field Measurements/Component Compliance

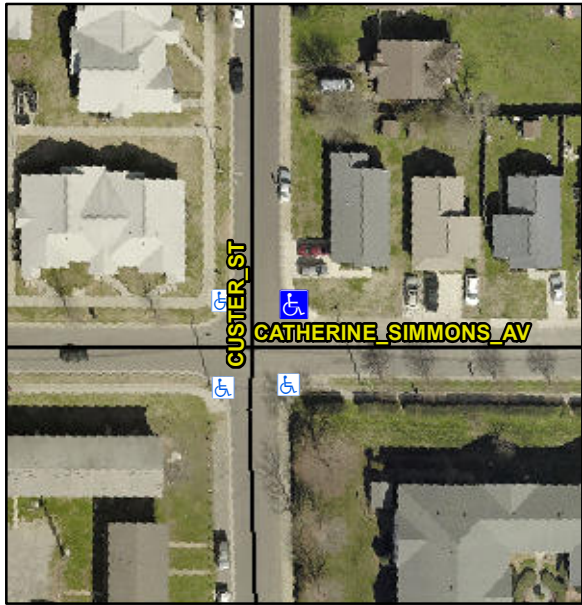
Compliance	Description	Data	Compliance	Description	Data
N/A	Ramp Length (in)	62.0	Yes	Ramp Slope (%)	6.4
Yes	Ramp Width (in)	80.0	No	Ramp XSlope (%)	5.5
N/A	Flare Type LT	N/A	N/A	Flare Type RT	N/A
N/A	Flare Slope LT (%)	N/A	N/A	Flare Slope RT (%)	N/A
N/A	Flare Traversable LT?	N/A	N/A	Flare Traversable RT?	N/A
N/A	Landing Length (in)	N/A	N/A	DWS Provided?	N/A
N/A	Landing Width (in)	N/A	N/A	DWS Contrast?	N/A
N/A	Landing Slope (%)	N/A	N/A	DWS Length (in)	N/A
N/A	Landing X Slope (%)	N/A	N/A	DWS Full Width?	N/A
N/A	Landing Curb? (Y/N)	N/A	N/A	DWS Offset (in)	N/A
N/A	Shared Landing?	N/A			
N/A	Gutter Ponding?	N/A	N/A	Gutter Slope (%)	N/A
N/A	Gutter Lip Ht (in)	N/A	N/A	Gutter X Slope (%)	N/A
N/A	Painted X Walk1?	No	N/A	Painted X Walk2?	No
	X Walk 1 Direction	To W		X Walk 2 Direction	To S
N/A	X Walk 1 Width (in)	N/A	N/A	X Walk 2 Width (in)	N/A
	X Walk 1 Slope (%)	2.6		X Walk 2 Slope (%)	1.7
	X Walk 1 X Slope (%)	0.6		X Walk 2 X Slope (%)	1.5

N/A	Ramp inside XWalk1?	N/A	N/A	Ramp inside XWalk2?	N/A
	Road Slope (%)	1.3	N/A	Clear Space?	N/A
	Road X Slope (%)	3.2	N/A	Clear Space to XWalk (in)	N/A
N/A	Any Obstructions?	N/A	N/A	Storm Grate/Utility Hazard?	N/A
	Obstruction Type			Storm Grate/Utility Type	
		N/A			N/A
			Yes	Surface Condition? (G/P)	Good

Possible Solutions:					
	Remove & Replace Curb Ramp With Two New Directional Ramps or Equivalent.					
	Surveyor Notes:					
	N/A					
	PROW/ADA:					
Not Found, R304.5.3						
Total Cost:		\$	3200.00
