# Access Compliance Report

## Public Rights-of-Way

### (Curb Ramps)

Intersection ID: 10353	Main Street: E_35TH_ST	Cross Street: N_MCDOWELL_ST	Location: N
ADA ID: 36D10565D024	Ramp Type: PerpDiag	Initial Pass/Fail: Fail	Overall Compliance: No
Severity Score: 13.75			
Codes/Mitigation Info/Possible Solution		Field Measurements/Component Compliance

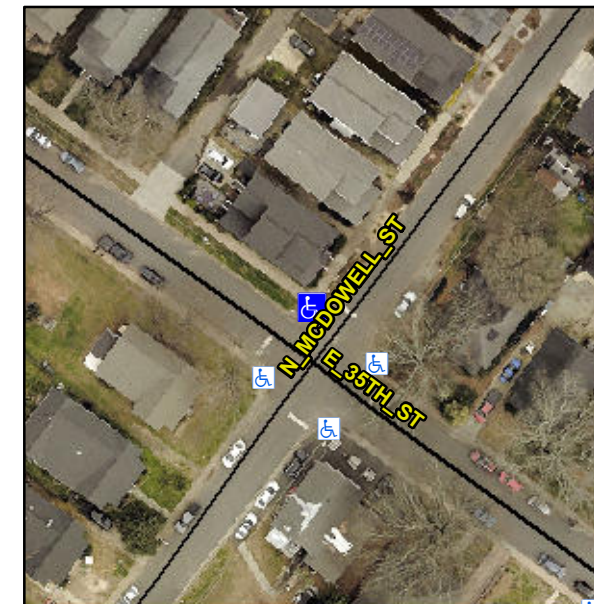
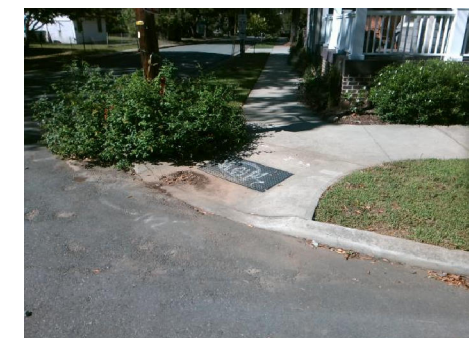
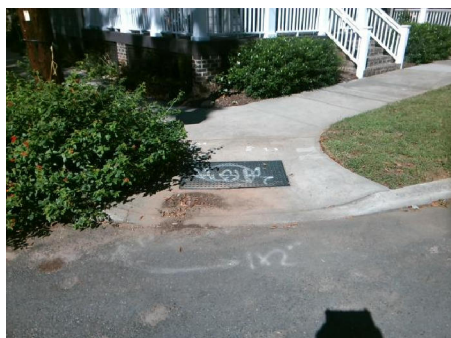
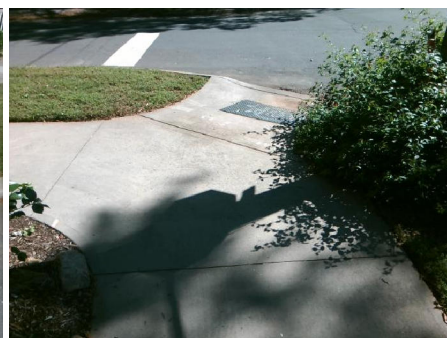
Compliance	Description	Data	Compliance	Description	Data
N/A	Ramp Length (in)	77.5	No	Ramp Slope (%)	11.9
Yes	Ramp Width (in)	48.0	No	Ramp XSlope (%)	2.3
N/A	Flare Type LT	N/A	N/A	Flare Type RT	N/A
N/A	Flare Slope LT (%)	N/A	N/A	Flare Slope RT (%)	N/A
N/A	Flare Traversable LT?	N/A	N/A	Flare Traversable RT?	N/A
N/A	Landing Length (in)	N/A	N/A	DWS Provided?	N/A
N/A	Landing Width (in)	N/A	N/A	DWS Contrast?	N/A
N/A	Landing Slope (%)	N/A	N/A	DWS Length (in)	N/A
N/A	Landing X Slope (%)	N/A	N/A	DWS Full Width?	N/A
N/A	Landing Curb? (Y/N)	N/A	N/A	DWS Offset (in)	N/A
N/A	Shared Landing?	N/A			
N/A	Gutter Ponding?	N/A	N/A	Gutter Slope (%)	N/A
N/A	Gutter Lip Ht (in)	N/A	N/A	Gutter X Slope (%)	N/A
N/A	Painted X Walk1?	No	N/A	Painted X Walk2?	No
	X Walk 1 Direction	To SW		X Walk 2 Direction	To SE
N/A	X Walk 1 Width (in)	N/A	N/A	X Walk 2 Width (in)	N/A
	X Walk 1 Slope (%)	2.5		X Walk 2 Slope (%)	1.2
	X Walk 1 X Slope (%)	2.3		X Walk 2 X Slope (%)	1.6

N/A	Ramp inside XWalk1?	N/A	N/A	Ramp inside XWalk2?	N/A
	Road Slope (%)	2.2	N/A	Clear Space?	N/A
	Road X Slope (%)	2.7	N/A	Clear Space to XWalk (in)	N/A
N/A	Any Obstructions?	N/A	N/A	Storm Grate/Utility Hazard?	N/A
	Obstruction Type			Storm Grate/Utility Type	
		N/A			N/A
		Yes		Surface Condition? (G/P)	Good

**Remove & Replace Curb Ramp With Two New Directional Ramps or Equivalent.**

**R304.2.2, R304.5.3**
