# Access Compliance Report

## Public Rights-of-Way

| Intersection ID: 8987 | Main Street: GRIER_AV | Cross Street: WELCH_PL | Location: NW |
| ADA ID: 36D7D81804E4 | Ramp Type: Perp | Initial Pass/Fail: Fail | Overall Compliance: No |

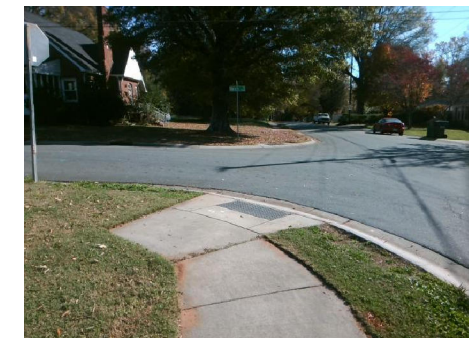
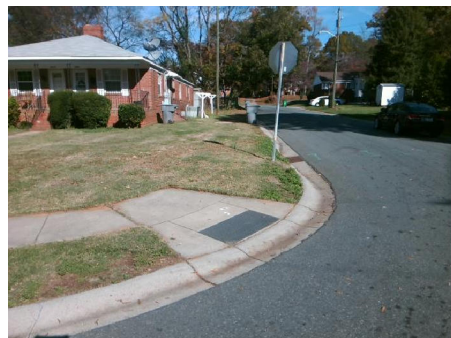
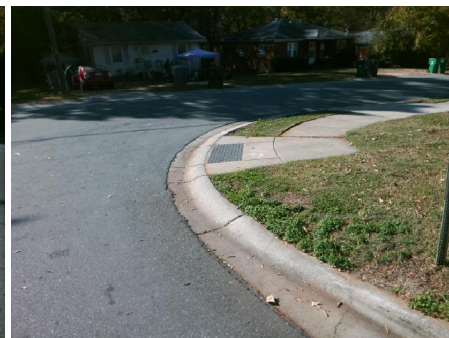
**Not Found, R304.5.1, R304.5.3**

| Compliance | Description | Data | Compliance | Description | Data |
|---|---|---|---|---|---|
| No | Ramp Width (in) | 46.0 | No | Ramp XSlope (%) | 4.7 |

**Remove & Replace Entire Ramp.**

Total Cost: \$ 1850.00
