Access Compliance Report

Public Rights-of-Way

(Curb Ramps)

Intersection ID: 45152	Main Street: REID_OAKS_DR	Cross Street: REID_PARK_LN	Location: SW
ADA ID: 36D8617B35C0	Ramp Type: PerpDiag	Initial Pass/Fail: Fail	Overall Compliance: No
Severity Score: 8.75			
Codes/Mitigation Info/Possible Solution		Field Measurements/Component Compliance

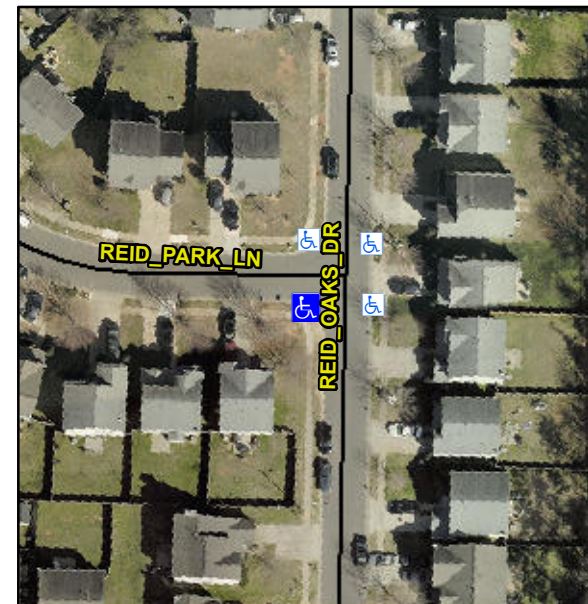
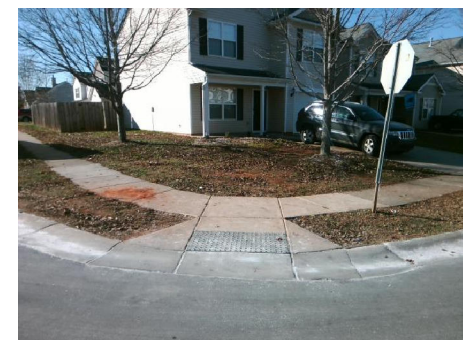
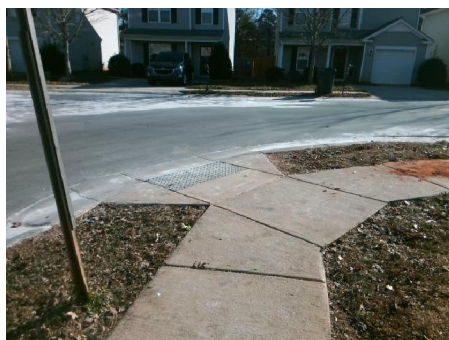
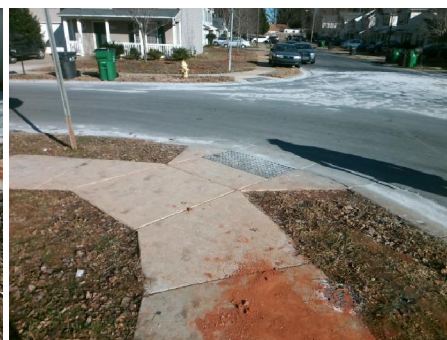
Not Found, R304.5.1

Compliance	Description	Data	Compliance	Description	Data
N/A	Ramp Length (in)	46.0	Yes	Ramp Slope (%)	5.7
No	Ramp Width (in)	47.5	Yes	Ramp XSlope (%)	1.4
N/A	Flare Type LT	N/A	N/A	Flare Type RT	N/A
N/A	Flare Slope LT (%)	N/A	N/A	Flare Slope RT (%)	N/A
N/A	Flare Traversable LT?	N/A	N/A	Flare Traversable RT?	N/A
N/A	Landing Length (in)	N/A	N/A	DWS Provided?	N/A
N/A	Landing Width (in)	N/A	N/A	DWS Contrast?	N/A
N/A	Landing Slope (%)	N/A	N/A	DWS Length (in)	N/A
N/A	Landing X Slope (%)	N/A	N/A	DWS Full Width?	N/A
N/A	Landing Curb? (Y/N)	N/A	N/A	DWS Offset (in)	N/A
N/A	Shared Landing?	N/A			
N/A	Gutter Ponding?	N/A	N/A	Gutter Slope (%)	N/A
N/A	Gutter Lip Ht (in)	N/A	N/A	Gutter X Slope (%)	N/A
N/A	Painted X Walk1?	No	N/A	Painted X Walk2?	No
	X Walk 1 Direction	To E		X Walk 2 Direction	To N
N/A	X Walk 1 Width (in)	N/A	N/A	X Walk 2 Width (in)	N/A
	X Walk 1 Slope (%)	5.4		X Walk 2 Slope (%)	2.8
	X Walk 1 X Slope (%)	0.7		X Walk 2 X Slope (%)	4.8

N/A	Ramp inside XWalk1?	N/A	N/A	Ramp inside XWalk2?	N/A
	Road Slope (%)	3.0	N/A	Clear Space?	N/A
	Road X Slope (%)	6.3	N/A	Clear Space to XWalk (in)	N/A
N/A	Any Obstructions?	N/A	N/A	Storm Grate/Utility Hazard?	N/A
	Obstruction Type			Storm Grate/Utility Type	
		N/A			N/A
			Yes	Surface Condition? (G/P)	Good

Remove & Replace Curb Ramp With Two New Directional Ramps or Equivalent.
