# Access Compliance Report

## Public Rights-of-Way

### (Curb Ramps)

Intersection ID: 51615	Main Street: BENFIELD_RD	Cross Street: PROSPERITY_CHURCH_RD	Location: NW
ADA ID: 36E763DF6307	Ramp Type: BlendTrans1	Initial Pass/Fail: Pass	Overall Compliance: No
		Severity Score: 0.25

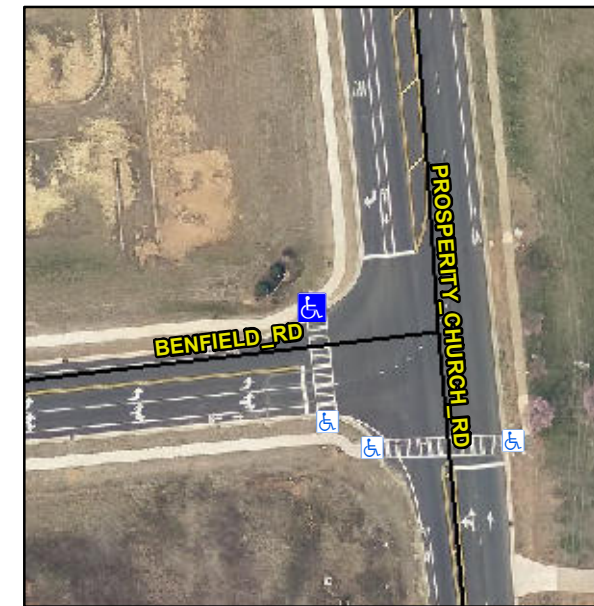
Compliance	Description	Data	Compliance	Description	Data
N/A	Ramp Length (in)	26.0	Yes	BlendTrans Slope (%)	2.6
Yes	Ramp Width (in)	48.0	Yes	BlendTrans XSlope (%)	2.1
N/A	Flare Type LT	Sloped	N/A	Flare Type RT	Sloped
N/A	Flare Slope LT (%)	3.3	N/A	Flare Slope RT (%)	7.9
N/A	Flare Traversable LT?	No	N/A	Flare Traversable RT?	No
Yes	Landing Length (in)	70.0	Yes	DWS Provided?	Yes
Yes	Landing Width (in)	48.0	Yes	DWS Contrast?	Yes
Yes	Landing Slope (%)	2.0	Yes	DWS Length (in)	24.0
Yes	Landing X Slope (%)	1.7	Yes	DWS Full Width?	Yes
N/A	Landing Curb? (Y/N)	No	Yes	DWS Offset (in)	1.0
N/A	Shared Landing?	No			
Yes	Gutter Ponding?	No	Yes	Gutter Slope (%)	2.5
Yes	Gutter Lip Ht (in)	0.0	Yes	Gutter X Slope (%)	1.8
N/A	Painted X Walk1?	Yes	N/A	Painted X Walk2?	N/A
	X Walk 1 Direction	To S		X Walk 2 Direction	N/A
	X Walk 1 Width (in)	112.0		X Walk 2 Width (in)	N/A
	X Walk 1 Slope (%)	3.4		X Walk 2 Slope (%)	N/A
	X Walk 1 X Slope (%)	4.1		X Walk 2 X Slope (%)	N/A

Yes	Ramp inside XWalk1?	Yes	N/A	Ramp inside XWalk2?	N/A
	Road Slope (%)	4.1		Clear Space?	Yes
	Road X Slope (%)	3.4	N/A	Clear Space to XWalk (in)	N/A
Yes	Any Obstructions?	No	Yes	Storm Grate/Utility Hazard?	No
	Obstruction Type			Storm Grate/Utility Type	
		N/A			N/A
			Yes	Surface Condition? (G/P)	Good
			No	Curb Slope (%)	10.8

Possible Solutions:

**Remove & Replace Curb Slope and Extend Ramp.**
