Access Compliance Report Public Rights-of-Way (Curb Ramps)

Intersection ID: 47910 Main Street: ROOK RD Cross Street: MOUNTAIN_QUAIL_DR Location: W ADA ID: 36ECEF77DCB2 Ramp Type: BlendTrans2 Initial Pass/Fail: Fail **Overall Compliance: No Severity Score:** 17.5

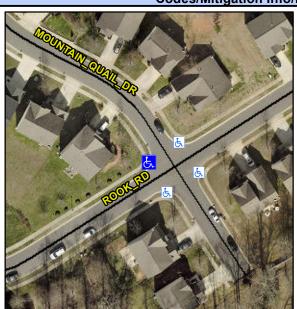
BlendTrans Slope (%)

17/7	rtamp Length (m)	33.3	163	Diena Hans Slope (70)	7.7
No	Ramp Width (in)	35.0	Yes	BlendTrans XSlope (%)	0.9
N/A	Flare Type LT	N/A	N/A	Flare Type RT	N/A
N/A	Flare Slope LT (%)	N/A	N/A	Flare Slope RT (%)	N/A
N/A	Flare Traversable LT?	N/A	N/A	Flare Traversable RT?	N/A
N/A	Landing Length (in)	N/A	N/A	DWS Provided?	N/A
N/A	Landing Width (in)	N/A	N/A	DWS Contrast?	N/A
N/A	Landing Slope (%)	N/A	N/A	DWS Length (in)	N/A
N/A	Landing X Slope (%)	N/A	N/A	DWS Full Width?	N/A
N/A	Landing Curb? (Y/N)	N/A	N/A	DWS Offset (in)	N/A
N/A	Shared Landing?	N/A			
N/A	Gutter Ponding?	N/A	N/A	Gutter Slope (%)	N/A
N/A	Gutter Lip Ht (in)	N/A	N/A	Gutter X Slope (%)	N/A
N/A	Painted X Walk1?	No	N/A	Painted X Walk2?	No
	X Walk 1 Direction	To NE		X Walk 2 Direction	To SE
	X Walk 1 Width (in)	N/A		X Walk 2 Width (in)	N/A
	X Walk 1 Slope (%)	2.4		X Walk 2 Slope (%)	1.5
	X Walk 1 X Slope (%)	3.5		X Walk 2 X Slope (%)	2.2
N/A	Ramp inside XWalk1?	N/A	N/A	Ramp inside XWalk2?	N/A

Road Slope (%)	3.6		Clear Space?	N/A
	Road X Slope (%)	3.5	N/A	Clear Space to XWalk (in)	N/A
N/A	Any Obstructions?	N/A	N/A	Storm Grate/Utility Hazard?	N/A
	Obstruction Type		l	Storm Grate/Utility Type	
		N/A			N/A
			Yes	Surface Condition? (G/P)	Good
			N/A	Curb Slope (%)	3.9
The state of the

Remove & Replace Curb Ramp With Two New Directional Ramps or Equivalent. Surveyor Notes: N/A PROW/ADA: R304.5.1
