## **Access Compliance Report Public Rights-of-Way** (Curb Ramps)

Intersection ID: 28882 Main Street: EDEN HALL CT Cross Street: GEORGIAN HALL DR Location: SW ADA ID: 36FD41DBA751 Ramp Type: Perp Initial Pass/Fail: Pass **Overall Compliance: No Severity Score:** 30

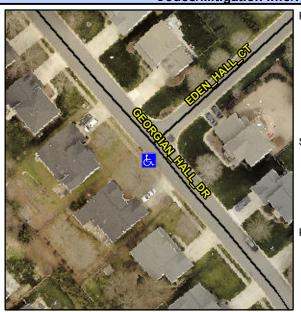
| Field Measurements/Component Compliance | | | | | |
|---|---|---|---|---|---|
| Yes | Landing Length (in) | 48.0 | No | DWS Provided? | No |
| No | Landing Slope (%) | 3.5 | N/A | DWS Length (in) | N/A |
| Yes | Gutter Ponding? | No | No | Gutter Slope (%) | 10.6 |
| No | Gutter Lip Ht (in) | 1.0 | No | Gutter X Slope (%) | 2.3 |

Possible Solutions: Remove & Replace Entire Ramp. Remove & Replace Gutter. Surveyor Notes: N/A PROW/ADA: Not Found, R304.2.2-Perp, R304.3.2-Para, R305, R302.7.2, R304.5.4, R304.5.3

Total Cost: 2600.00
