Access Compliance Report

Public Rights-of-Way

(Curb Ramps)

Intersection ID: 43735	Main Street: BELMONT_WALK_WY	Cross Street: BRIDGEVIEW_LN	Location: SE
ADA ID: 3704FD223AB9	Ramp Type: PerpDiag	Initial Pass/Fail: Fail	Overall Compliance: No
		Severity Score: 22.5

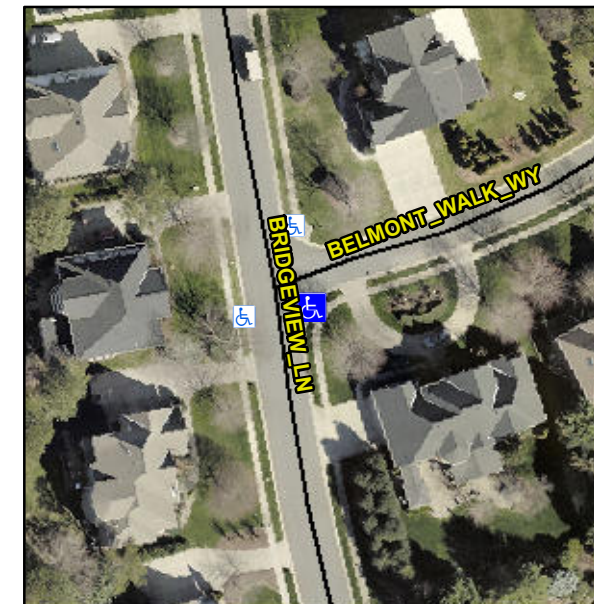
Not Found, R304.5.1, R304.2.2, R304.5.3

Compliance	Description	Data	Compliance	Description	Data
N/A	Ramp Length (in)	48.0	No	Ramp Slope (%)	8.4
No	Ramp Width (in)	43.0	No	Ramp XSlope (%)	3.9
N/A	Flare Type LT	N/A	N/A	Flare Type RT	N/A
N/A	Flare Slope LT (%)	N/A	N/A	Flare Slope RT (%)	N/A
N/A	Flare Traversable LT?	N/A	N/A	Flare Traversable RT?	N/A
N/A	Landing Length (in)	N/A	N/A	DWS Provided?	N/A
N/A	Landing Width (in)	N/A	N/A	DWS Contrast?	N/A
N/A	Landing Slope (%)	N/A	N/A	DWS Length (in)	N/A
N/A	Landing X Slope (%)	N/A	N/A	DWS Full Width?	N/A
N/A	Landing Curb? (Y/N)	N/A	N/A	DWS Offset (in)	N/A
N/A	Shared Landing?	N/A			
N/A	Gutter Ponding?	N/A	N/A	Gutter Slope (%)	N/A
N/A	Gutter Lip Ht (in)	N/A	N/A	Gutter X Slope (%)	N/A
N/A	Painted X Walk1?	No	N/A	Painted X Walk2?	No
	X Walk 1 Direction	To N		X Walk 2 Direction	To W
N/A	X Walk 1 Width (in)	N/A	N/A	X Walk 2 Width (in)	N/A
	X Walk 1 Slope (%)	3.3		X Walk 2 Slope (%)	1.5
	X Walk 1 X Slope (%)	0.6		X Walk 2 X Slope (%)	3.1

N/A	Ramp inside XWalk1?	N/A	N/A	Ramp inside XWalk2?	N/A
	Road Slope (%)	2.8	N/A	Clear Space?	N/A
	Road X Slope (%)	2.0	N/A	Clear Space to XWalk (in)	N/A
N/A	Any Obstructions?	N/A	N/A	Storm Grate/Utility Hazard?	N/A
	Obstruction Type			Storm Grate/Utility Type	
		N/A			N/A
			Yes	Surface Condition? (G/P)	Good

Remove & Replace Curb Ramp With Two New Directional Ramps or Equivalent.

Total Cost: \$ 3200.00
