Access Compliance Report Public Rights-of-Way (Curb Ramps)

Intersection ID: 12957 Main Street: HAMORTON_PL Cross Street: PECAN_AV Location: SW ADA ID: 3716C86961EB Ramp Type: PerpDiag Initial Pass/Fail: Fail **Overall Compliance: No Severity Score:** 12.5

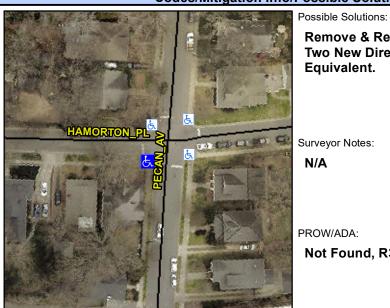
Not Found, R304.2.2

Field Measurements/Component Compliance						
Compliance Description		Data	Compliance Description		Data	
N/A	Ramp Length (in)	98.0	No	Ramp Slope (%)	9.3	
Yes	Ramp Width (in)	48.0	Yes	Ramp XSlope (%)	1.1	
N/A	Flare Type LT	N/A	N/A	Flare Type RT	N/A	
N/A	Flare Slope LT (%)	N/A	N/A	Flare Slope RT (%)	N/A	
N/A	Flare Traversable LT?	N/A	N/A	Flare Traversable RT?	N/A	
N/A	Landing Length (in)	N/A	N/A	DWS Provided?	N/A	
N/A	Landing Width (in)	N/A	N/A	DWS Contrast?	N/A	
N/A	Landing Slope (%)	N/A	N/A	DWS Length (in)	N/A	
N/A	Landing X Slope (%)	N/A	N/A	DWS Full Width?	N/A	
N/A	Landing Curb? (Y/N)	N/A	N/A	DWS Offset (in)	N/A	
N/A	Shared Landing?	N/A				
N/A	Gutter Ponding?	Yes	N/A	Gutter Slope (%)	N/A	
N/A	Gutter Lip Ht (in)	N/A	N/A	Gutter X Slope (%)	N/A	
N/A	Painted X Walk1?	No	N/A	Painted X Walk2?	No	
	X Walk 1 Direction	To E		X Walk 2 Direction	To N	
N/A	X Walk 1 Width (in)	N/A	N/A	X Walk 2 Width (in)	N/A	
	X Walk 1 Slope (%)	10.2		X Walk 2 Slope (%)	1.2

X Walk 1 X Slope (%)	2.2		X Walk 2 X Slope (%)	2.8	
N/A	Ramp inside XWalk1?	N/A	N/A	Ramp inside XWalk2?	N/A	
	Road Slope (%)	0.0	N/A	Clear Space?	N/A	
	Road X Slope (%)	6.5	N/A	Clear Space to XWalk (in)	N/A	
N/A	Any Obstructions?	N/A	N/A	Storm Grate/Utility Hazard?	N/A	
	Obstruction Type			Storm Grate/Utility Type		
		N/A			N/A	
			Yes	Surface Condition? (G/P)	Good

Remove & Replace Curb Ramp With Two New Directional Ramps or Equivalent. Surveyor Notes:
