# Access Compliance Report

## Public Rights-of-Way

### (Curb Ramps)

Intersection ID: 3625	Main Street: SANDRINGHAM_PL	Cross Street: CHOWNING_TAVERN_LN	Location:	N
ADA ID: 372AF29963AB	Ramp Type: Perp	Initial Pass/Fail: Fail	Overall Compliance: No	Severity Score: 33.75
Codes/Mitigation Info/Possible Solution		Field Measurements/Component Compliance

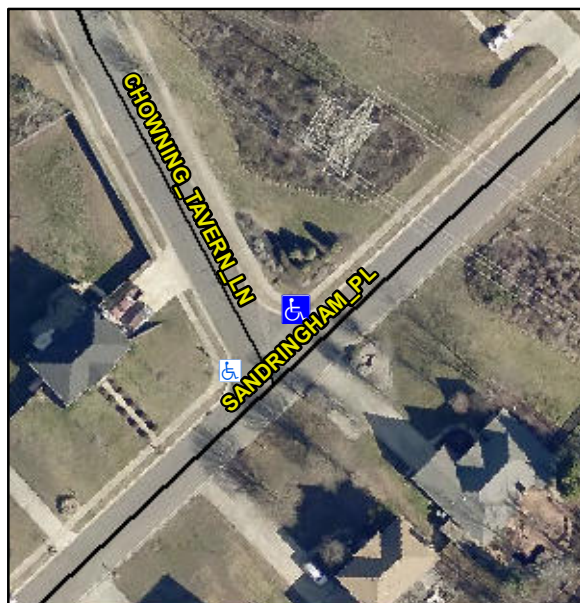
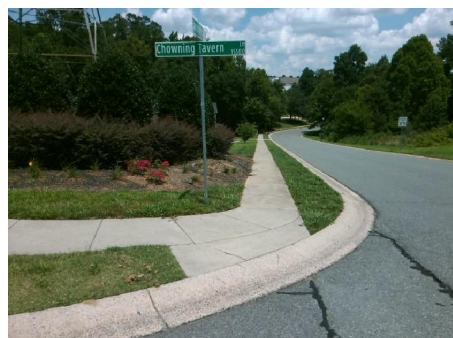
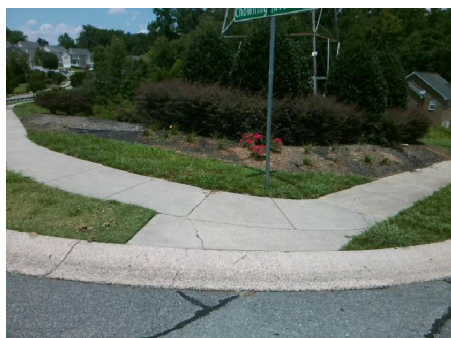
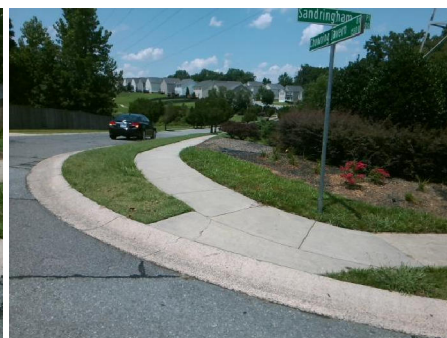
**Not Found, R304.5.1, R304.5.3**

Compliance	Description	Data	Compliance	Description	Data
N/A	Ramp Length (in)	71.0	Yes	Ramp Slope (%)	5.1
No	Ramp Width (in)	36.0	No	Ramp XSlope (%)	7.8
N/A	Flare Type LT	N/A	N/A	Flare Type RT	N/A
N/A	Flare Slope LT (%)	N/A	N/A	Flare Slope RT (%)	N/A
N/A	Flare Traversable LT?	N/A	N/A	Flare Traversable RT?	N/A
N/A	Landing Length (in)	N/A	N/A	DWS Provided?	N/A
N/A	Landing Width (in)	N/A	N/A	DWS Contrast?	N/A
N/A	Landing Slope (%)	N/A	N/A	DWS Length (in)	N/A
N/A	Landing X Slope (%)	N/A	N/A	DWS Full Width?	N/A
N/A	Landing Curb? (Y/N)	N/A	N/A	DWS Offset (in)	N/A
N/A	Shared Landing?	N/A			
N/A	Gutter Ponding?	N/A	N/A	Gutter Slope (%)	N/A
N/A	Gutter Lip Ht (in)	N/A	N/A	Gutter X Slope (%)	N/A
N/A	Painted X Walk1?	No	N/A	Painted X Walk2?	N/A
	X Walk 1 Direction	To SW		X Walk 2 Direction	N/A
N/A	X Walk 1 Width (in)	N/A	N/A	X Walk 2 Width (in)	N/A
	X Walk 1 Slope (%)	10.2		X Walk 2 Slope (%)	N/A
	X Walk 1 X Slope (%)	2.2		X Walk 2 X Slope (%)	N/A

N/A	Ramp inside XWalk1?	N/A	N/A	Ramp inside XWalk2?	N/A
	Road Slope (%)	N/A	N/A	Clear Space?	N/A
	Road X Slope (%)	N/A	N/A	Clear Space to XWalk (in)	N/A
N/A	Any Obstructions?	N/A	N/A	Storm Grate/Utility Hazard?	N/A
	Obstruction Type			Storm Grate/Utility Type	
		N/A			N/A
			Yes	Surface Condition? (G/P)	Good

**Remove & Replace Entire Ramp.**

Total Cost: \$ 1850.00
