Access Compliance Report

Public Rights-of-Way

(Curb Ramps)

Intersection ID: 53928	Main Street: PRESTON_KNOLL_LN	Cross Street: PINYON_PINE_LN	Location: NW
ADA ID: 372BADD11078	Ramp Type: BlendTrans1	Initial Pass/Fail: Fail	Overall Compliance: No
			Severity Score: 36.25

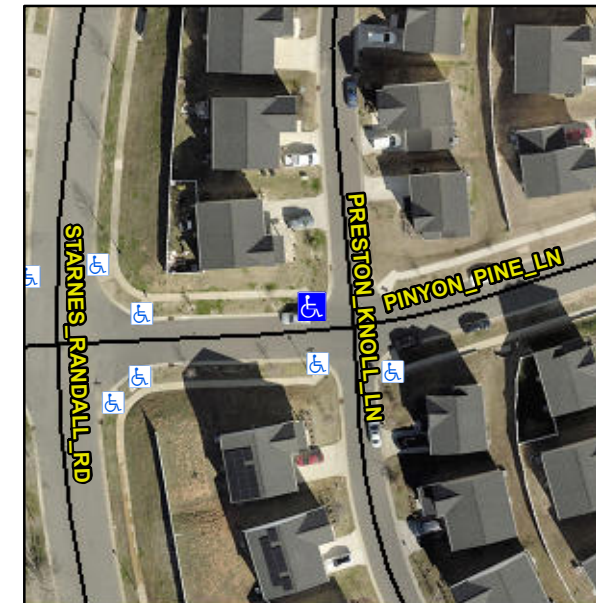
Not Found, R304.5.1, R304.5.3

Compliance	Description	Data	Compliance	Description	Data
N/A	Ramp Length (in)	93.5	Yes	BlendTrans Slope (%)	1.5
No	Ramp Width (in)	30.0	No	BlendTrans XSlope (%)	2.6
N/A	Flare Type LT	N/A	N/A	Flare Type RT	N/A
N/A	Flare Slope LT (%)	N/A	N/A	Flare Slope RT (%)	N/A
N/A	Flare Traversable LT?	N/A	N/A	Flare Traversable RT?	N/A
N/A	Landing Length (in)	N/A	N/A	DWS Provided?	N/A
N/A	Landing Width (in)	N/A	N/A	DWS Contrast?	N/A
N/A	Landing Slope (%)	N/A	N/A	DWS Length (in)	N/A
N/A	Landing X Slope (%)	N/A	N/A	DWS Full Width?	N/A
N/A	Landing Curb? (Y/N)	N/A	N/A	DWS Offset (in)	N/A
N/A	Shared Landing?	N/A			
N/A	Gutter Ponding?	N/A	N/A	Gutter Slope (%)	N/A
N/A	Gutter Lip Ht (in)	N/A	N/A	Gutter X Slope (%)	N/A
N/A	Painted X Walk1?	No	N/A	Painted X Walk2?	No
	X Walk 1 Direction	To S		X Walk 2 Direction	To E
	X Walk 1 Width (in)	N/A		X Walk 2 Width (in)	N/A
	X Walk 1 Slope (%)	4.1		X Walk 2 Slope (%)	6.2
	X Walk 1 X Slope (%)	5.9		X Walk 2 X Slope (%)	3.5

N/A	Ramp inside XWalk1?	N/A	N/A	Ramp inside XWalk2?	N/A
	Road Slope (%)	2.5		Clear Space?	N/A
	Road X Slope (%)	5.0	N/A	Clear Space to XWalk (in)	N/A
N/A	Any Obstructions?	N/A	N/A	Storm Grate/Utility Hazard?	N/A
	Obstruction Type			Storm Grate/Utility Type	
		N/A			N/A
			Yes	Surface Condition? (G/P)	Good
			No	Curb Slope (%)	9.4

Remove & Replace Curb Ramp With Two New Directional Ramps or Equivalent.

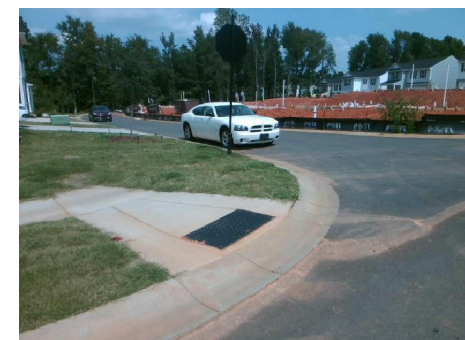
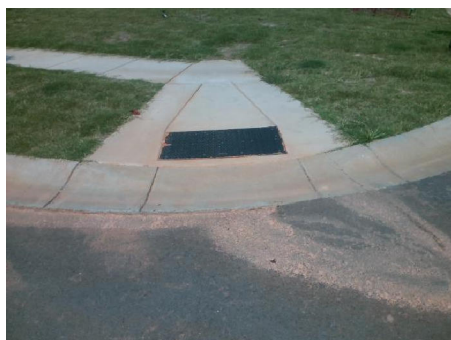
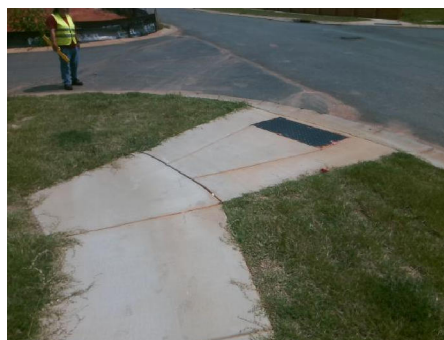
Street 1 Name PINYON PINE LN
 Stop Condition-Street 1 None
 Street 2 Name PRESTON KNOLL LN
 Stop Condition-Street 2 StopSign
