Access Compliance Report

Public Rights-of-Way

(Curb Ramps)

Intersection ID: N/A	Main Street: CANTERBURY_CASTLE_DR	Cross Street: NICHOLS_HALL	Location: NW
ADA ID: 37329233EFC2	Ramp Type: Perp	Initial Pass/Fail: Fail	Overall Compliance: No
Codes/Mitigation Info/Possible Solution		Field Measurements/Component Compliance	
Severity Score: 8.75

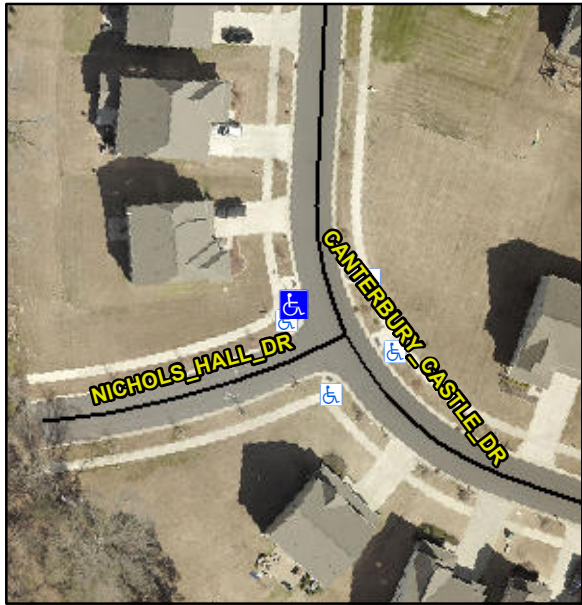
Compliance	Description	Data	Compliance	Description	Data
N/A	Ramp Length (in)	97.0	Yes	Ramp Slope (%)	8.1
No	Ramp Width (in)	46.5	Yes	Ramp XSlope (%)	0.7
N/A	Flare Type LT	N/A	N/A	Flare Type RT	N/A
N/A	Flare Slope LT (%)	N/A	N/A	Flare Slope RT (%)	N/A
N/A	Flare Traversable LT?	N/A	N/A	Flare Traversable RT?	N/A
N/A	Landing Length (in)	N/A	N/A	DWS Provided?	N/A
N/A	Landing Width (in)	N/A	N/A	DWS Contrast?	N/A
N/A	Landing Slope (%)	N/A	N/A	DWS Length (in)	N/A
N/A	Landing X Slope (%)	N/A	N/A	DWS Full Width?	N/A
N/A	Landing Curb? (Y/N)	N/A	N/A	DWS Offset (in)	N/A
N/A	Shared Landing?	N/A			
N/A	Gutter Ponding?	N/A	N/A	Gutter Slope (%)	N/A
N/A	Gutter Lip Ht (in)	N/A	N/A	Gutter X Slope (%)	N/A
N/A	Painted X Walk1?	No	N/A	Painted X Walk2?	N/A
	X Walk 1 Direction	To E		X Walk 2 Direction	N/A
N/A	X Walk 1 Width (in)	N/A	N/A	X Walk 2 Width (in)	N/A
	X Walk 1 Slope (%)	3.4		X Walk 2 Slope (%)	N/A
	X Walk 1 X Slope (%)	3.7		X Walk 2 X Slope (%)	N/A

N/A	Ramp inside XWalk1?	N/A	N/A	Ramp inside XWalk2?	N/A
	Road Slope (%)	N/A	N/A	Clear Space?	N/A
	Road X Slope (%)	N/A	N/A	Clear Space to XWalk (in)	N/A
N/A	Any Obstructions?	N/A	N/A	Storm Grate/Utility Hazard?	N/A
	Obstruction Type			Storm Grate/Utility Type	
		N/A			N/A
			Yes	Surface Condition? (G/P)	Good

Possible Solutions:			
	Remove & Replace Entire Ramp.			
	Surveyor Notes:			
	N/A			
	PROW/ADA:			
	R304.5.1			
	Total Cost:		\$	1850.00
	Street 1 Name		CANTERBURY CASTLE DR	
	Stop Condition-Street 2		None	
	Street 2 Name		N/A	
Stop Condition-Street 1		N/A

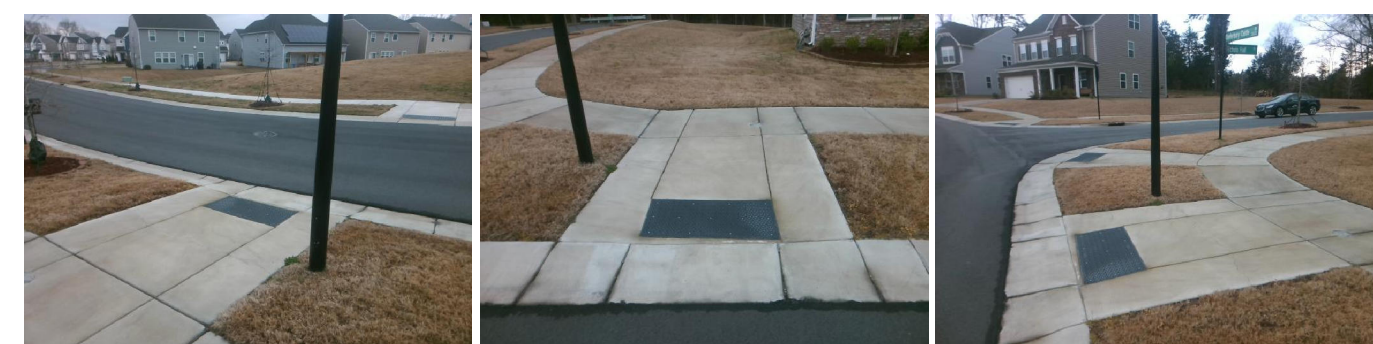
Compliance	Description	Data	Compliance	Description	Data
N/A	Ramp Length (in)	97.0	Yes	Ramp Slope (%)	8.1
No	Ramp Width (in)	46.5	Yes	Ramp XSlope (%)	0.7
N/A	Flare Type LT	N/A	N/A	Flare Type RT	N/A
N/A	Flare Slope LT (%)	N/A	N/A	Flare Slope RT (%)	N/A
N/A	Flare Traversable LT?	N/A	N/A	Flare Traversable RT?	N/A
N/A	Landing Length (in)	N/A	N/A	DWS Provided?	N/A
N/A	Landing Width (in)	N/A	N/A	DWS Contrast?	N/A
N/A	Landing Slope (%)	N/A	N/A	DWS Length (in)	N/A
N/A	Landing X Slope (%)	N/A	N/A	DWS Full Width?	N/A
N/A	Landing Curb? (Y/N)	N/A	N/A	DWS Offset (in)	N/A
N/A	Shared Landing?	N/A			
N/A	Gutter Ponding?	N/A	N/A	Gutter Slope (%)	N/A
N/A	Gutter Lip Ht (in)	N/A	N/A	Gutter X Slope (%)	N/A
N/A	Painted X Walk1?	No	N/A	Painted X Walk2?	N/A
	X Walk 1 Direction	To E		X Walk 2 Direction	N/A
N/A	X Walk 1 Width (in)	N/A	N/A	X Walk 2 Width (in)	N/A
	X Walk 1 Slope (%)	3.4		X Walk 2 Slope (%)	N/A
	X Walk 1 X Slope (%)	3.7		X Walk 2 X Slope (%)	N/A

N/A	Ramp inside XWalk1?	N/A	N/A	Ramp inside XWalk2?	N/A
	Road Slope (%)	N/A	N/A	Clear Space?	N/A
	Road X Slope (%)	N/A	N/A	Clear Space to XWalk (in)	N/A
N/A	Any Obstructions?	N/A	N/A	Storm Grate/Utility Hazard?	N/A
	Obstruction Type			Storm Grate/Utility Type	
		N/A			N/A
		Yes		Surface Condition? (G/P)	Good
