| Intersection ID: 50301 | Main Street: WINGED_TEAL_RD | Cross Street: PINE_CHAPEL_DR | Location: | NW |
| ADA ID: 3733595AE2A6 | Ramp Type: PerpDiag | Initial Pass/Fail: Fail | Overall Compliance: No | Severity Score: 21.25 |

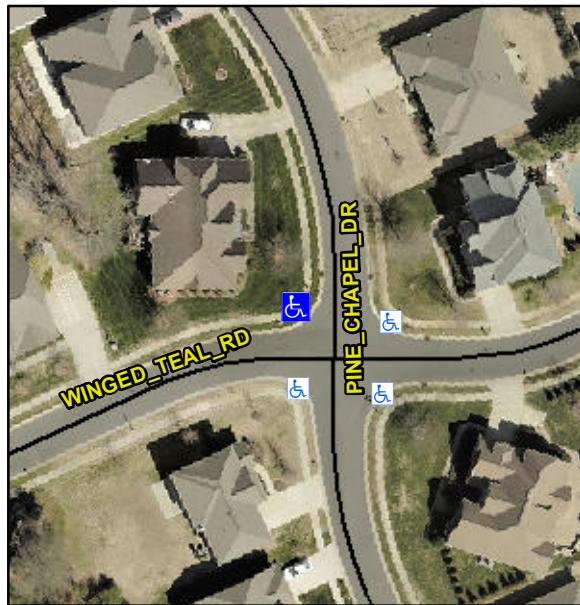
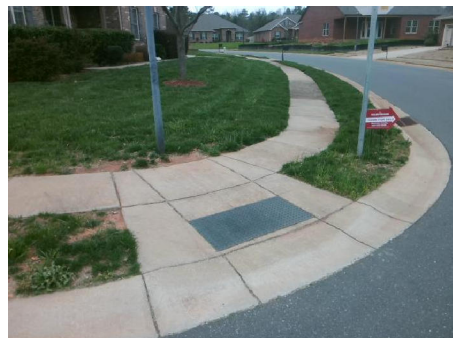
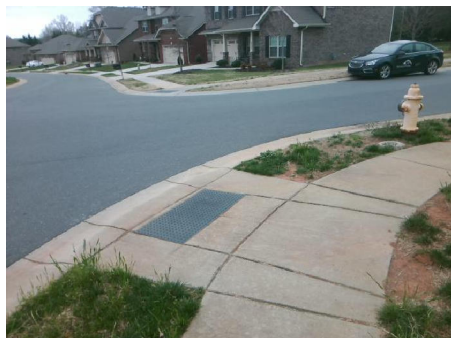
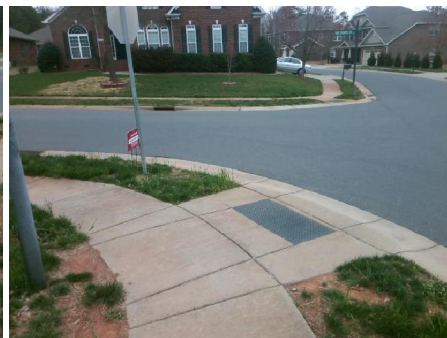
R304.5.1, R304.2.2

| Compliance | Description | Data | Compliance | Description | Data |
|---|---|---|---|---|---|
| N/A | Ramp Length (in) | 48.0 | No | Ramp Slope (%) | 8.9 |
| No | Ramp Width (in) | 46.5 | Yes | Ramp XSlope (%) | 1.4 |

Remove & Replace Curb Ramp With Two New Directional Ramps or Equivalent.

Total Cost: \$ 3200.00
