## **Access Compliance Report Public Rights-of-Way** (Curb Ramps)

Intersection ID: 20942 Main Street: CORONATION BV **Cross Street: CROWN CENTRE DR** Location: NE ADA ID: 373640690141 Ramp Type: PerpDiag Initial Pass/Fail: Fail **Overall Compliance: No Severity Score:** 25

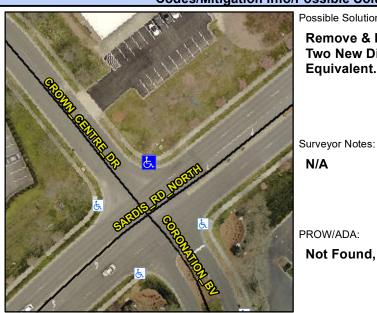
Compliance Description Data		Comp	iance Desc	ription	Data	
N/A	Ramp Length (in)	68.0	No	Ramp Slope	∈ (%)	8.4
Yes	Ramp Width (in)	48.0	No	Ramp XSIo	pe (%)	6.4
N/A	Flare Type LT	N/A	N/A	Flare Type RT		N/A
N/A	Flare Slope LT (%)	N/A	N/A	Flare Slope RT (%)		N/A
N/A	Flare Traversable LT?	N/A	N/A	Flare Traversable RT?		N/A
N/A	Landing Length (in)	N/A	N/A	DWS Provid	ded?	N/A
N/A	Landing Width (in)	N/A	N/A	DWS Contr	ast?	N/A
N/A	Landing Slope (%)	N/A	N/A	DWS Lengt	h (in)	N/A
N/A	Landing X Slope (%)	N/A	N/A	DWS Full V	/idth?	N/A
N/A	Landing Curb? (Y/N)	N/A	N/A	DWS Offset	t (in)	N/A
N/A	Shared Landing?	N/A				
N/A	Gutter Ponding?	N/A	N/A	Gutter Slop	e (%)	N/A
N/A	Gutter Lip Ht (in)	N/A	N/A	Gutter X Slo	ope (%)	N/A
N/A	Painted X Walk1?	No	N/A	Painted X V	Valk2?	No
	X Walk 1 Direction	To SW		X Walk 2 Di	rection	To SE
N/A	X Walk 1 Width (in)	N/A	N/A	X Walk 2 W	idth (in)	N/A
	X Walk 1 Slope (%)	6.4		X Walk 2 SI	ope (%)	1.7

X Walk 1 X Slope (%)	5.7		X Walk 2 X	Slope (%)	5.4
N/A	Ramp inside XWalk1?	N/A	N/A	Ramp insid	e XWalk2?	N/A
	Road Slope (%)	3.3	N/A	Clear Space	e?	N/A
	Road X Slope (%)	4.8	N/A	Clear Space	e to XWalk (in)	N/A
N/A	Any Obstructions?	N/A	N/A	Storm Grate	e/Utility Hazard?	N/A
	Obstruction Type		l	Storm Grate	e/Utility Type	
		N/A				N/A
			Yes	Surface Co	ndition? (G/P)	Good

Possible Solutions: Remove & Replace Curb Ramp With Two New Directional Ramps or Equivalent.

Not Found, R304.2.2, R304.5.3
