Access Compliance Report

Public Rights-of-Way (Curb Ramps)

Intersection ID: 10031554	Main Street: MEACHAM_ST	Cross Street: N/A	Location: NW
ADA ID: 37409A5E017E	Ramp Type: Directional1	Initial Pass/Fail: Fail	Overall Compliance: No
		Severity Score: 8.75

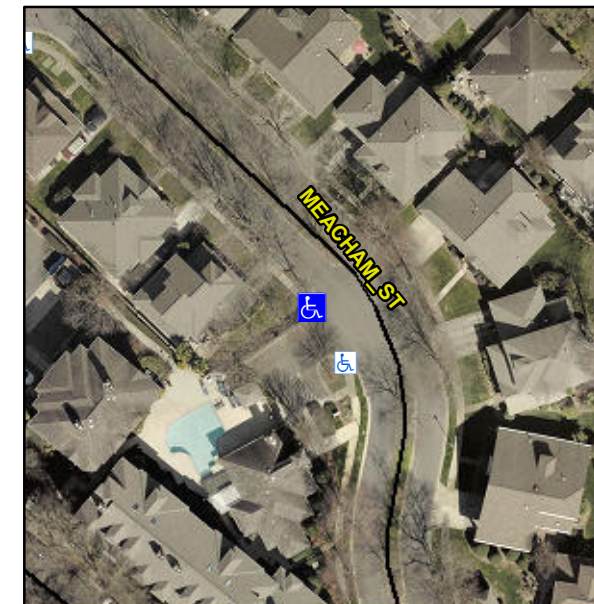
Compliance	Description	Data	Compliance	Description	Data
N/A	Ramp Length (in)	49.0	N/A	Grade Break?	N/A
No	Ramp Width (in)	38.0	N/A	Grade Break Slope (%)	0.0
Yes	Ramp Slope (%)	5.8	N/A	Grade Break XSlope (%)	0.0
Yes	Ramp XSlope (%)	1.1			
N/A	Flare Type LT	N/A	N/A	Flare Type RT	N/A
N/A	Flare Slope LT (%)	N/A	N/A	Flare Slope RT (%)	0.0
N/A	Flare Traversable LT?	N/A	N/A	Flare Traversable RT?	N/A
N/A	Landing Length (in)	0.0	N/A	DWS Provided?	N/A
N/A	Landing Width (in)	0.0	N/A	DWS Contrast?	N/A
N/A	Landing Slope (%)	0.0	N/A	DWS Length (in)	N/A
N/A	Landing X Slope (%)	0.0	N/A	DWS Full Width?	N/A
N/A	Landing Curb? (Y/N)	N/A	N/A	DWS Offset LT (in)	N/A
N/A	Shared Landing?	N/A	N/A	DWS Offset RT (in)	N/A
N/A	Gutter Ponding?	0.0	N/A	Gutter Slope (%)	N/A
N/A	Gutter Lip Ht (in)	0.0	N/A	Gutter X Slope (%)	N/A
N/A	Painted X Walk1?	No		Road Slope (%)	0.2
	X Walk 1 Direction	To SE		Road X Slope (%)	2.7
	X Walk 1 Width (in)	N/A		Clear Space?	N/A

X Walk 1 Slope (%)	0.2	N/A	Clear Space to XWalk (in)	N/A
	X Walk 1 X Slope (%)	2.7	N/A	Storm Grate/Utility Hazard?	N/A
N/A	Ramp inside XWalk1?	N/A		Storm Grate/Utility Type	
N/A	Any Obstructions?	N/A			N/A
	Obstruction Type		Yes	Surface Condition? (G/P)	Good
			N/A	Curb Slope (%)	5.0

Possible Solutions:

Remove & Replace Entire Ramp.
