Access Compliance Report

Public Rights-of-Way

(Curb Ramps)

Intersection ID: N/A	Main Street: BEVINGTON_PL	Cross Street: N/A	Location: SW
ADA ID: 375A60F39F27	Ramp Type: Perp	Initial Pass/Fail: Fail	Overall Compliance: No
Severity Score: 13.75			
Codes/Mitigation Info/Possible Solution		Field Measurements/Component Compliance

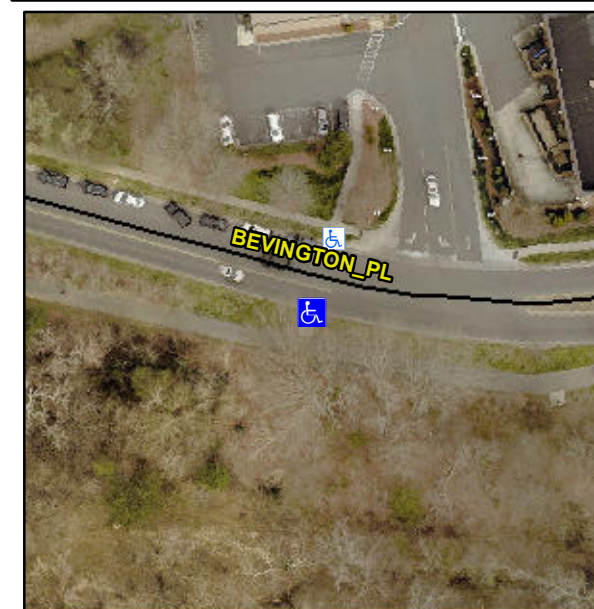
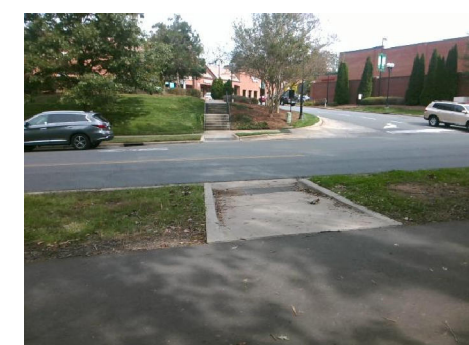
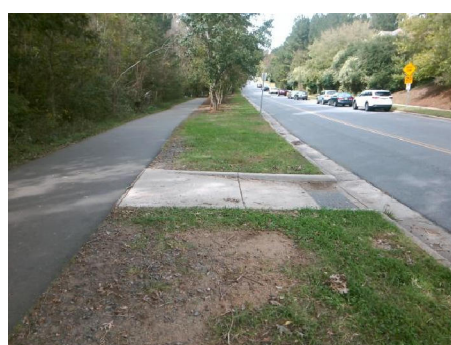
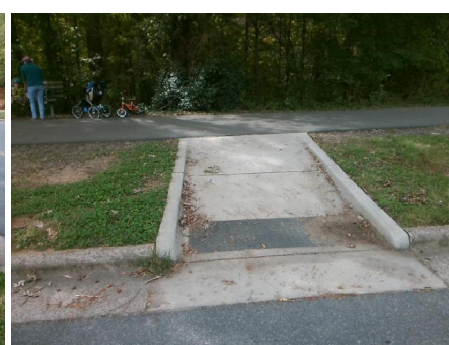
R304.2.2, R304.5.3

Compliance	Description	Data	Compliance	Description	Data
N/A	Ramp Length (in)	155.0	No	Ramp Slope (%)	10.9
Yes	Ramp Width (in)	82.5	No	Ramp XSlope (%)	4.6
N/A	Flare Type LT	N/A	N/A	Flare Type RT	N/A
N/A	Flare Slope LT (%)	N/A	N/A	Flare Slope RT (%)	N/A
N/A	Flare Traversable LT?	N/A	N/A	Flare Traversable RT?	N/A
N/A	Landing Length (in)	N/A	N/A	DWS Provided?	N/A
N/A	Landing Width (in)	N/A	N/A	DWS Contrast?	N/A
N/A	Landing Slope (%)	N/A	N/A	DWS Length (in)	N/A
N/A	Landing X Slope (%)	N/A	N/A	DWS Full Width?	N/A
N/A	Landing Curb? (Y/N)	N/A	N/A	DWS Offset (in)	N/A
N/A	Shared Landing?	N/A			
N/A	Gutter Ponding?	N/A	N/A	Gutter Slope (%)	N/A
N/A	Gutter Lip Ht (in)	N/A	N/A	Gutter X Slope (%)	N/A
N/A	Painted X Walk1?	No	N/A	Painted X Walk2?	N/A
	X Walk 1 Direction	To NE		X Walk 2 Direction	N/A
N/A	X Walk 1 Width (in)	N/A	N/A	X Walk 2 Width (in)	N/A
	X Walk 1 Slope (%)	5.2		X Walk 2 Slope (%)	N/A
	X Walk 1 X Slope (%)	2.5		X Walk 2 X Slope (%)	N/A

N/A	Ramp inside XWalk1?	N/A	N/A	Ramp inside XWalk2?	N/A
	Road Slope (%)	N/A	N/A	Clear Space?	N/A
	Road X Slope (%)	N/A	N/A	Clear Space to XWalk (in)	N/A
N/A	Any Obstructions?	N/A	N/A	Storm Grate/Utility Hazard?	N/A
	Obstruction Type			Storm Grate/Utility Type	
		N/A			N/A
			Yes	Surface Condition? (G/P)	Good

Remove & Replace Entire Ramp.
