# Access Compliance Report

## Public Rights-of-Way

### (Curb Ramps)

| Intersection ID: 45310 | Main Street: BENFIELD_RD | Cross Street: RIDGE_RD | Location: NW |

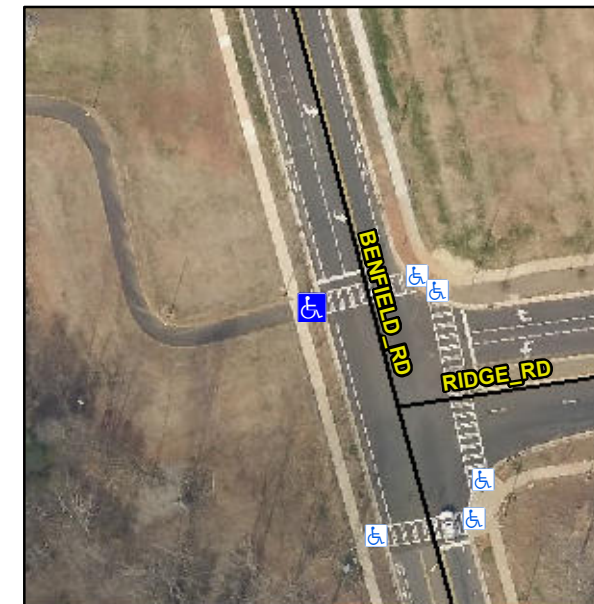
| ADA ID: 376B786BEF29 | Ramp Type: Perp | Initial Pass/Fail: Pass | Overall Compliance: No |

| Compliance | Description | Data | Compliance | Description | Data |
|---|---|---|---|---|---|
| No | Landing Slope (%) | 2.3 | Yes | DWS Length (in) | 24.0 |
| N/A | Landing Curb? (Y/N) | No | No | DWS Offset (in) | 2.5 |

**Remove & Replace Entire Ramp.**

**R304.2.2-Perp, R304.3.2-Para, R305.2**

Total Cost: \$ 1850.00
