# Access Compliance Report

## Public Rights-of-Way

### (Curb Ramps)

Intersection ID: 44296	Main Street: PEACH_PARK_LN	Cross Street: CRANDON_DR	Location: NE
ADA ID: 376E535A0E81	Ramp Type: PerpDiag	Initial Pass/Fail: Fail	Overall Compliance: No
Severity Score: 10			
Codes/Mitigation Info/Possible Solution		Field Measurements/Component Compliance

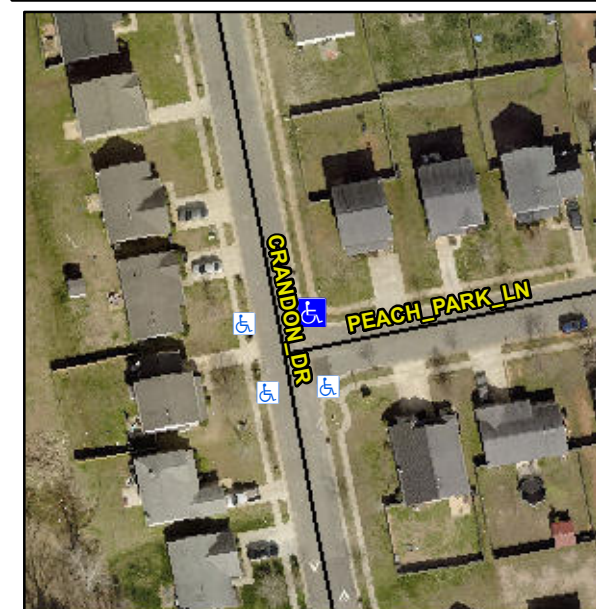
**Not Found, R304.5.1, R304.5.3**

Compliance	Description	Data	Compliance	Description	Data
N/A	Ramp Length (in)	49.0	Yes	Ramp Slope (%)	7.4
No	Ramp Width (in)	46.5	No	Ramp XSlope (%)	3.6
N/A	Flare Type LT	N/A	N/A	Flare Type RT	N/A
N/A	Flare Slope LT (%)	N/A	N/A	Flare Slope RT (%)	N/A
N/A	Flare Traversable LT?	N/A	N/A	Flare Traversable RT?	N/A
N/A	Landing Length (in)	N/A	N/A	DWS Provided?	N/A
N/A	Landing Width (in)	N/A	N/A	DWS Contrast?	N/A
N/A	Landing Slope (%)	N/A	N/A	DWS Length (in)	N/A
N/A	Landing X Slope (%)	N/A	N/A	DWS Full Width?	N/A
N/A	Landing Curb? (Y/N)	N/A	N/A	DWS Offset (in)	N/A
N/A	Shared Landing?	N/A			
N/A	Gutter Ponding?	N/A	N/A	Gutter Slope (%)	N/A
N/A	Gutter Lip Ht (in)	N/A	N/A	Gutter X Slope (%)	N/A
N/A	Painted X Walk1?	No	N/A	Painted X Walk2?	No
	X Walk 1 Direction	To W		X Walk 2 Direction	To S
N/A	X Walk 1 Width (in)	N/A	N/A	X Walk 2 Width (in)	N/A
	X Walk 1 Slope (%)	3.2		X Walk 2 Slope (%)	3.2
	X Walk 1 X Slope (%)	2.7		X Walk 2 X Slope (%)	0.7

N/A	Ramp inside XWalk1?	N/A	N/A	Ramp inside XWalk2?	N/A
	Road Slope (%)	0.5	N/A	Clear Space?	N/A
	Road X Slope (%)	1.0	N/A	Clear Space to XWalk (in)	N/A
N/A	Any Obstructions?	N/A	N/A	Storm Grate/Utility Hazard?	N/A
	Obstruction Type			Storm Grate/Utility Type	
		N/A			N/A
		Yes		Surface Condition? (G/P)	Good

**Remove & Replace Curb Ramp With Two New Directional Ramps or Equivalent.**

Total Cost: \$ 3200.00
