Access Compliance Report

Public Rights-of-Way

(Curb Ramps)

Intersection ID: 52365	Main Street: DUNAVANT_ST	Cross Street: MERVE_PL	Location: NE
ADA ID: 37921F5F1EF2	Ramp Type: Directional1	Initial Pass/Fail: Fail	Overall Compliance: No
Codes/Mitigation Info/Possible Solution		Field Measurements/Component Compliance	
Severity Score: 1.25

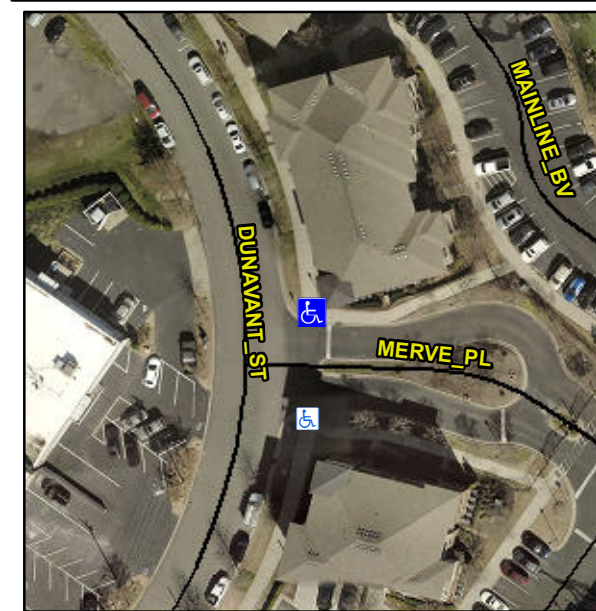
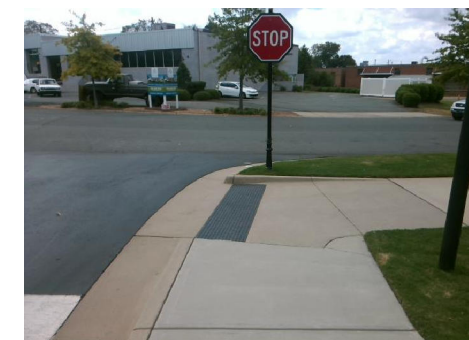
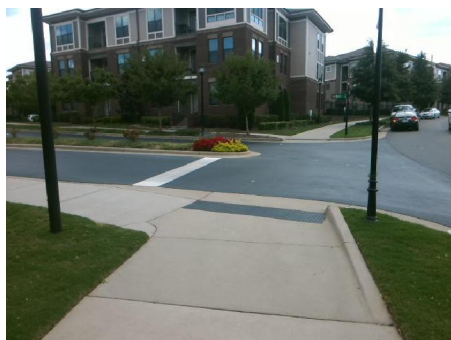
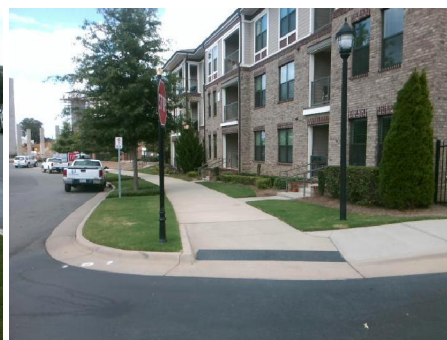
Compliance	Description	Data	Compliance	Description	Data
N/A	Ramp Length (in)	64.0	N/A	Grade Break?	N/A
Yes	Ramp Width (in)	96.0	N/A	Grade Break Slope (%)	0.0
Yes	Ramp Slope (%)	5.3	N/A	Grade Break XSlope (%)	0.0
No	Ramp XSlope (%)	2.5			
N/A	Flare Type LT	N/A	N/A	Flare Type RT	N/A
N/A	Flare Slope LT (%)	N/A	N/A	Flare Slope RT (%)	0.0
N/A	Flare Traversable LT?	N/A	N/A	Flare Traversable RT?	N/A
N/A	Landing Length (in)	0.0	N/A	DWS Provided?	N/A
N/A	Landing Width (in)	0.0	N/A	DWS Contrast?	N/A
N/A	Landing Slope (%)	0.0	N/A	DWS Length (in)	N/A
N/A	Landing X Slope (%)	0.0	N/A	DWS Full Width?	N/A
N/A	Landing Curb? (Y/N)	N/A	N/A	DWS Offset LT (in)	N/A
N/A	Shared Landing?	N/A	N/A	DWS Offset RT (in)	N/A
N/A	Gutter Ponding?	0.0	N/A	Gutter Slope (%)	N/A
N/A	Gutter Lip Ht (in)	0.0	N/A	Gutter X Slope (%)	N/A
N/A	Painted X Walk1?	No		Road Slope (%)	1.7
	X Walk 1 Direction	To SE		Road X Slope (%)	2.3
	X Walk 1 Width (in)	N/A		Clear Space?	N/A

X Walk 1 Slope (%)	1.7	N/A	Clear Space to XWalk (in)	N/A
	X Walk 1 X Slope (%)	2.3	N/A	Storm Grate/Utility Hazard?	N/A
N/A	Ramp inside XWalk1?	N/A		Storm Grate/Utility Type	
N/A	Any Obstructions?	N/A			N/A
	Obstruction Type		Yes	Surface Condition? (G/P)	Good
			N/A	Curb Slope (%)	0.6

Possible Solutions:

Remove & Replace Entire Ramp.

R304.5.3
